# Play Area Safety Inspection Report - Operational

Oakham Town Council - Willow Crescent Play Area

# February 2021

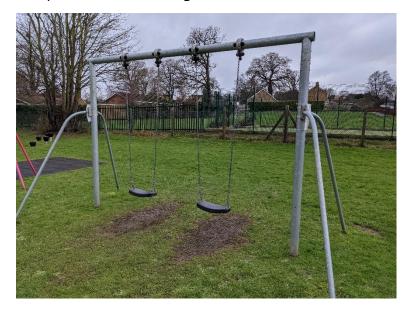
#### 1 Bay 2 Flat Seat Swing

Observations - Missing caps on crossbar. Recommend replacement

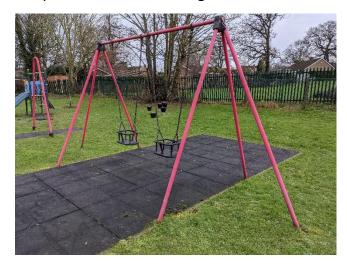
#### 1 Bay 2 Cradle Seat Swing

Observations - Rubber tiles are prone to getting extremely slippery throughout Autumn / Winter. Recommend monitoring during weekly checks.

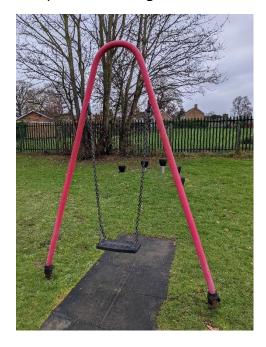
#### 1 Bay 1 Seat Swing

Observations - Rubber tiles are prone to getting extremely slippery throughout Autumn / Winter. Recommend monitoring during weekly checks.

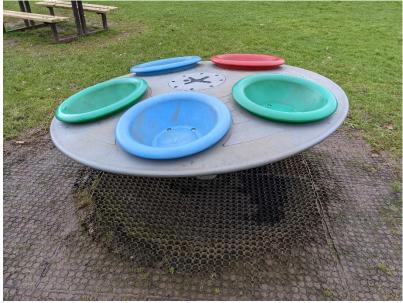
Observations - Monitor grass mats for separation leading to trip hazards.

Risk - Low
