Play Area Safety Inspection Report – Operational Oakham Town Council – Cutts Close Play Area

The inspection was carried out by Iain Mantle – RPII Certified Operational Playground Inspector OP8020 - Date of Inspection 16th June 2023

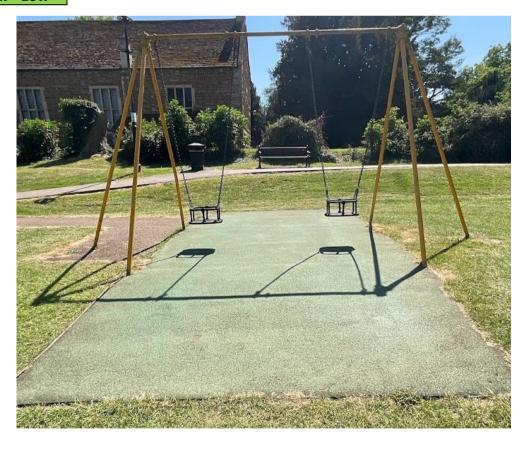
Item of Equipment-1 Bay 2 Cradle Seat Swing

Findings - Right hand swing has small split at the bottom of support strap

Risk - Low

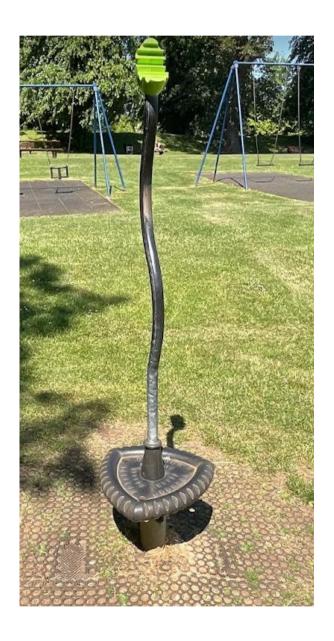
Item of Equipment- Spinning Pole

Findings – Slight play in bearing

Risk - Low

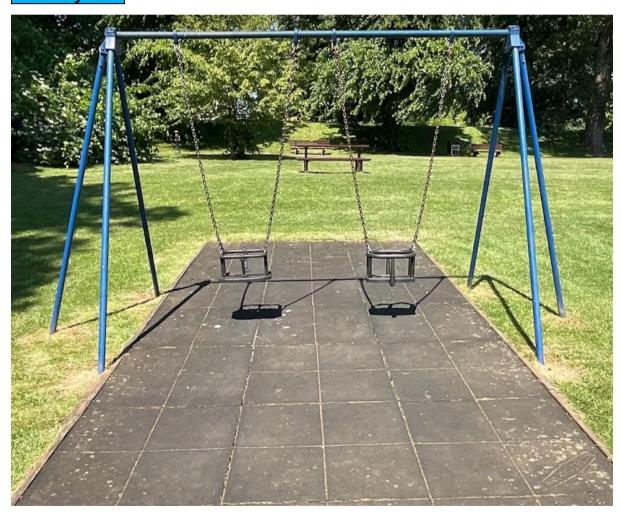
Item of Equipment-1 Bay 2 Cradle Seat Swing

Findings – Rubber tiles are prone to being extremely slippery when wet, Recommend monitor weekly during Autunm and winter months.

Risk Very Low

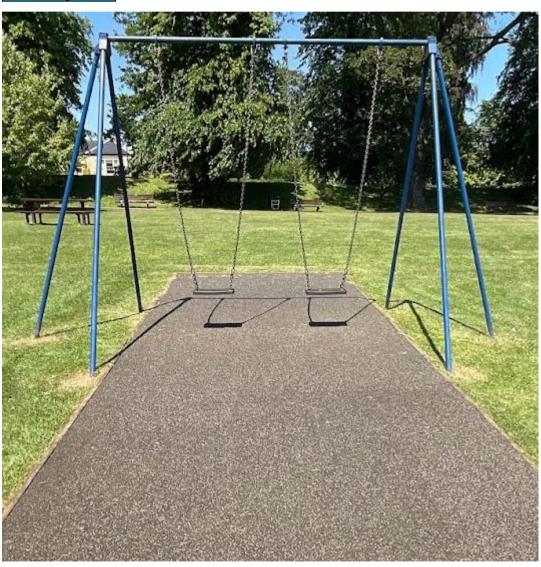
Item of Equipment-1 Bay 2 Flat Swings

Findings – Rubber wetpour safety surface shrinking away from concrete edge

Risk Very Low

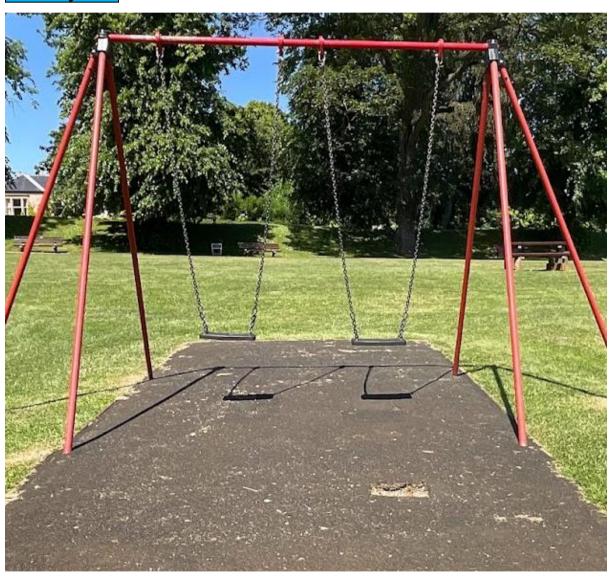
Item of Equipment-1 Bay 2 Flat Swings

Findings – Rubber wetpour safety surface shrinking away from concrete edge, hole in safety surface exposing a trip hazard and loose stone.

Risk Very Low

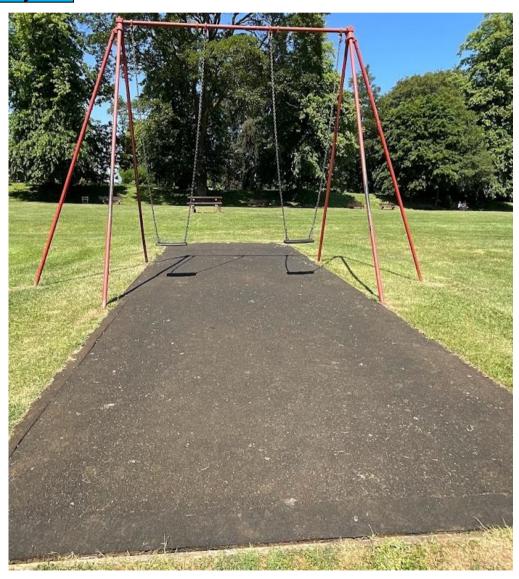
Item of Equipment-1 Bay 2 Flat Swings

Findings – Rubber wetpour safety surface shrinking away from concrete edge, and split also a small hole has appeared

Risk Very Low

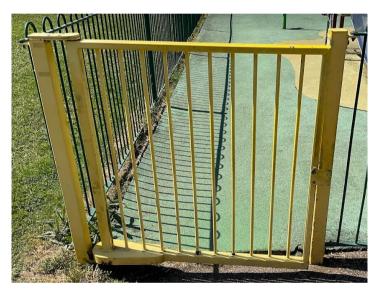
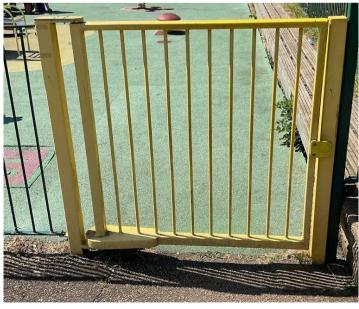
Item of Equipment- Under 5's Entrance Gate

Findings - Closing mechanism has failed. Requires new closer

Second gate operates satisfactory

Risk - Low

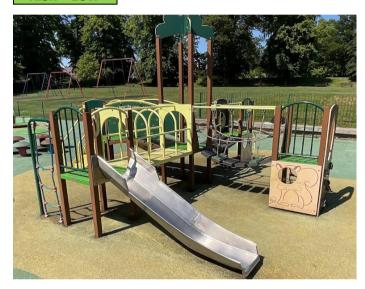
Item of Equipment- Toddler Multi-Play Unit

Findings – Split in one of the play panels. Substantial wear on the rope nets. Shrinkage on rubber wetpour surface.

Risk - Low

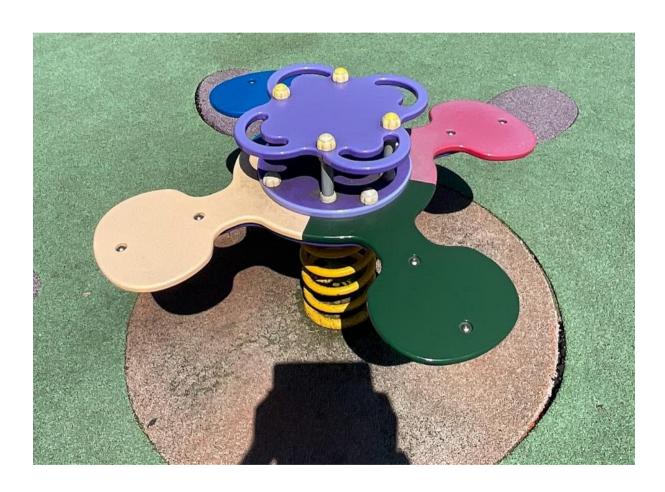
Item of Equipment- 4-Way Springer

Findings – Rubber wetpour safety surface is separating

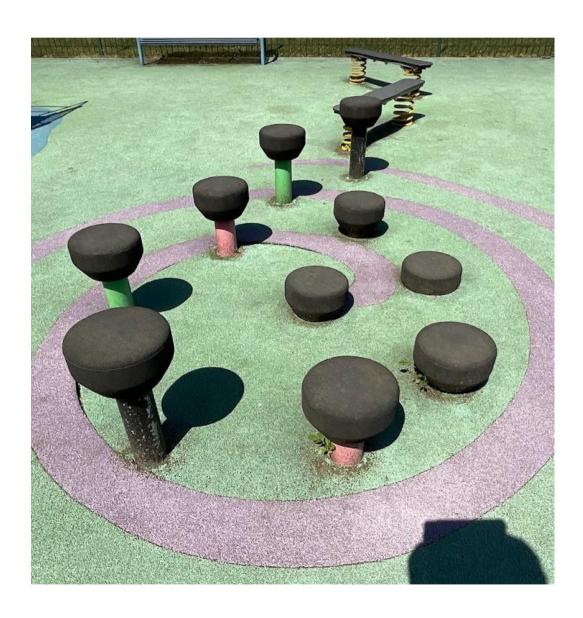
Item of Equipment- Rubber steps

Findings – Central rubber step has slight movement recommend monitoring, wetpour showing signs of separation

Risk Very Low

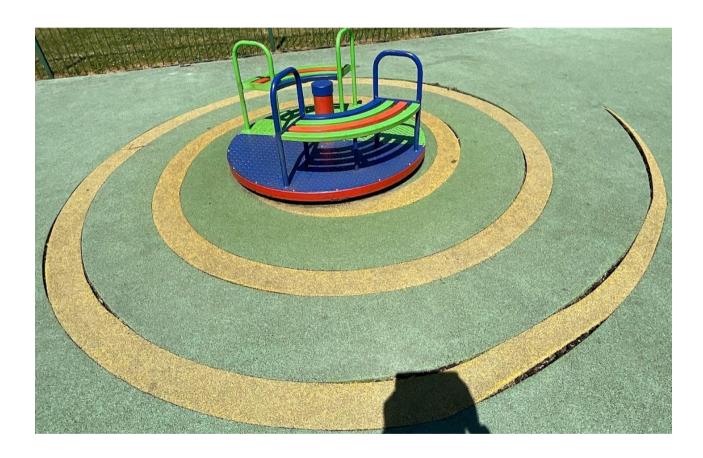
Item of Equipment- Roundabout

Findings – Roundabout bearings showing signs of wear extremely difficult to rotate, rubber wetpour surface showing signs of separation.

Risk - Low

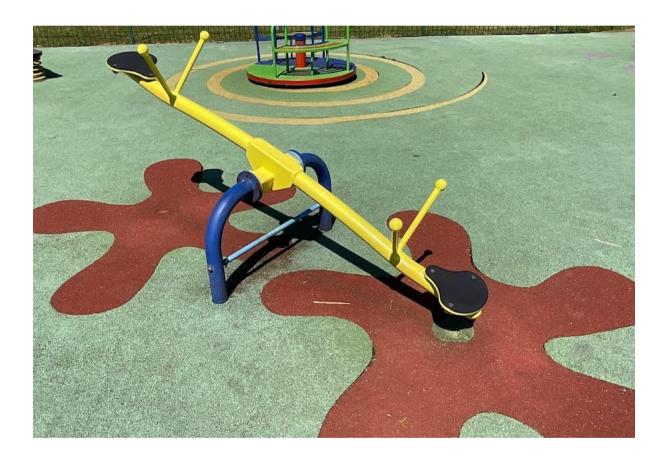
Item of Equipment- See Saw

Findings – Rubber wetpour showing slight signs of separation, bearing stiff very hard to move

Risk - Low

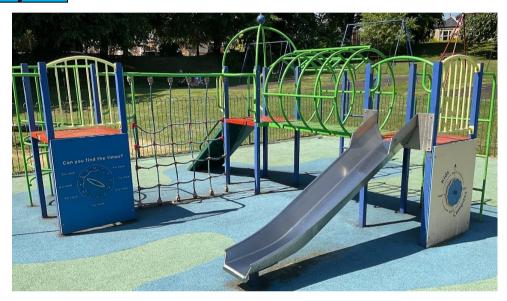
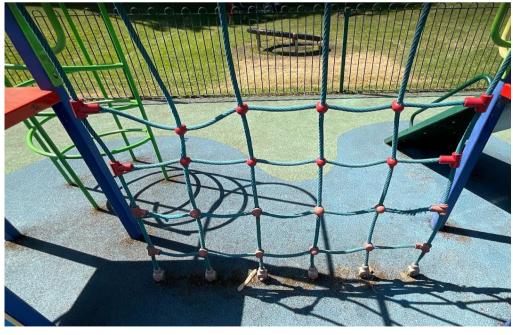
Item of Equipment – Junior Multi-play

Findings - Rope net worn exposing inner steel core

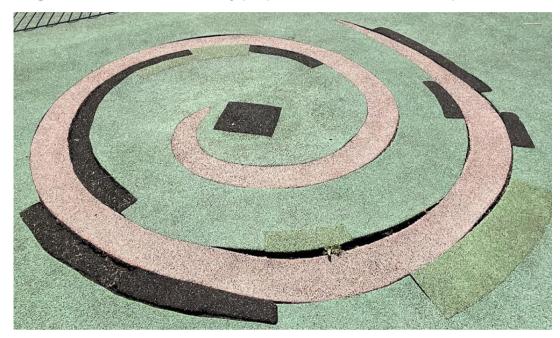
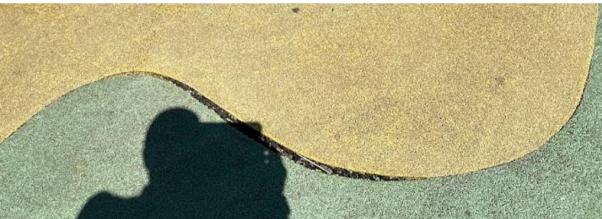
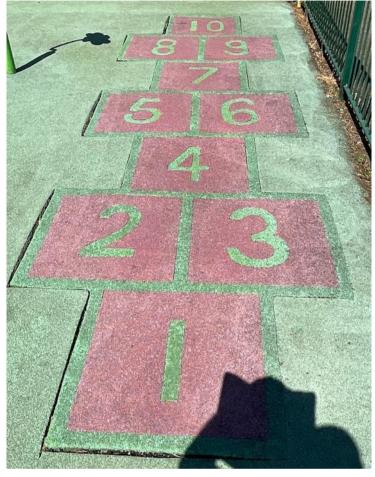
The rubber wetpour safety surface in the under 5's play area has badly deteriorated and has really come to the end of its life. I recommend the council look at options for replacing sooner than later for safety purposes. Please see attached photos.
