Play Area Safety Inspection Report – Operational  
Oakham Town Council – Princess Avenue Main Play Area

The inspection was carried out by Iain Mantle – RPII Certified Operational  
Playground Inspector OP8020 - Date of Inspection 16th June 2023

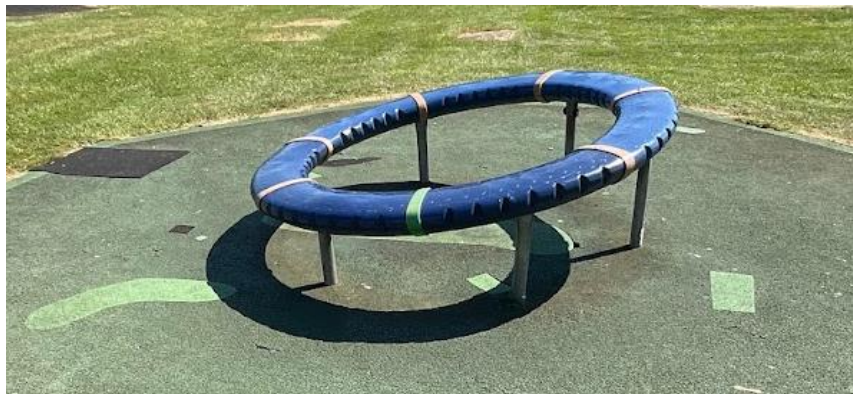
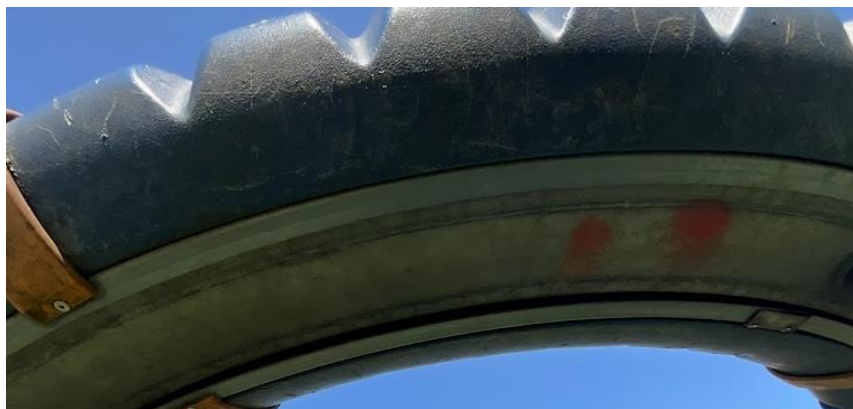
**Item of Equipment-Supernova**

**Findings – Rubber seal missing potential finger trap, rubber wetpour safety surface is showing signs of separation**

**Risk - Low**

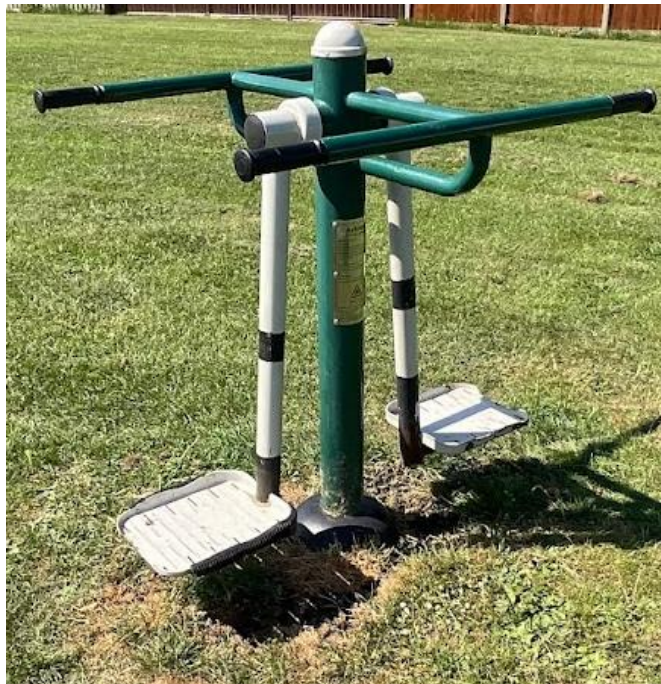
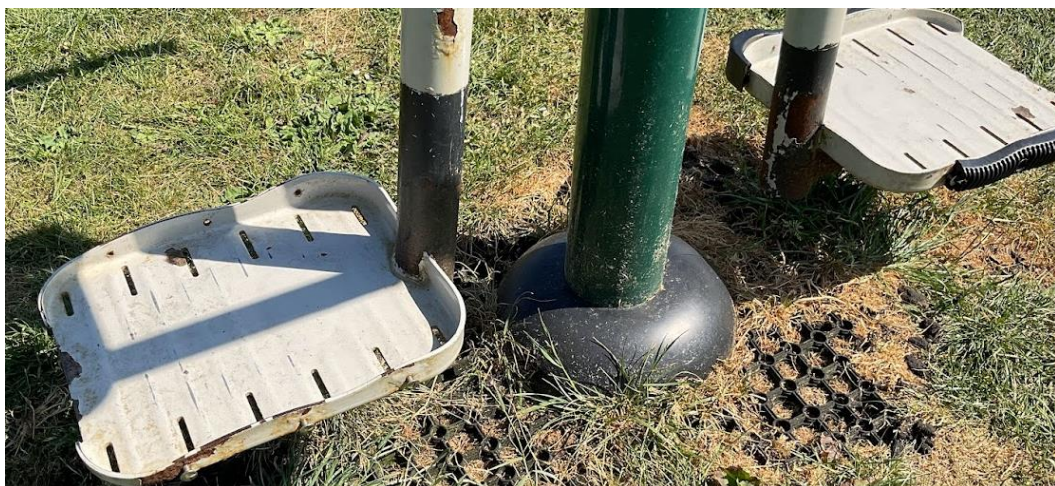
**Item of Equipment – Air Skier**

**Findings – Signs of wear and tear, and corrosion monitor for deterioration**

**Risk Very Low**
