Play Area Safety Inspection Report – Operational
Oakham Town Council – Princess Avenue Main Play Area

The inspection was carried out by Iain Mantle – RPII Certified Operational
Playground Inspector OP8020 - Date of Inspection 7th November 2023

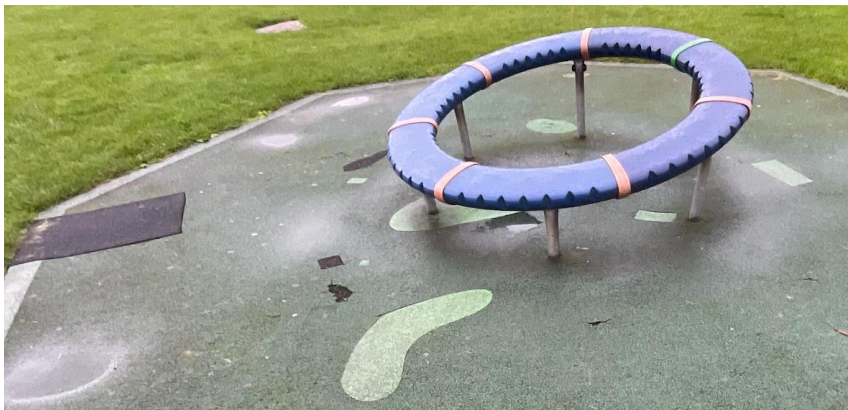
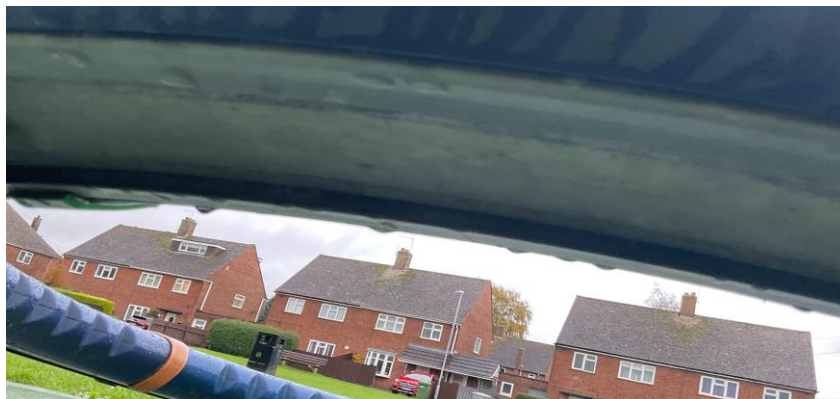
Item of Equipment-Supernova

Findings – Rubber seal missing potential finger trap, rubber wetpour safety surface has had previous repairs and is showing signs of separation around the edges

Risk - Low

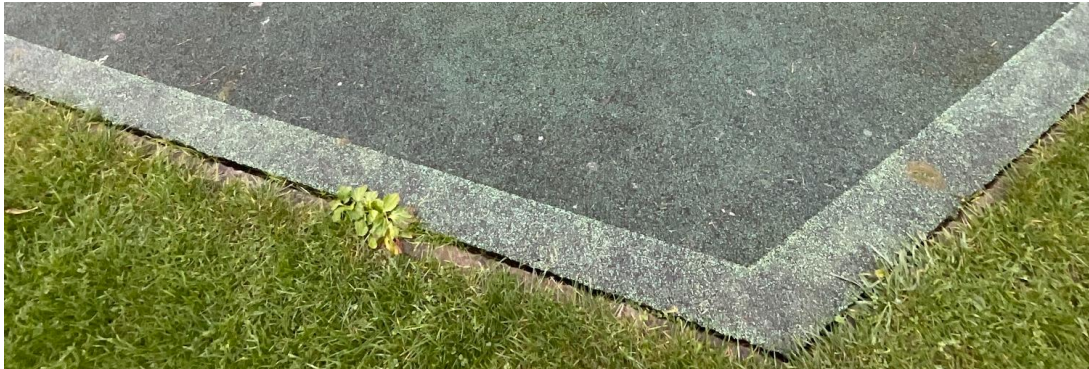
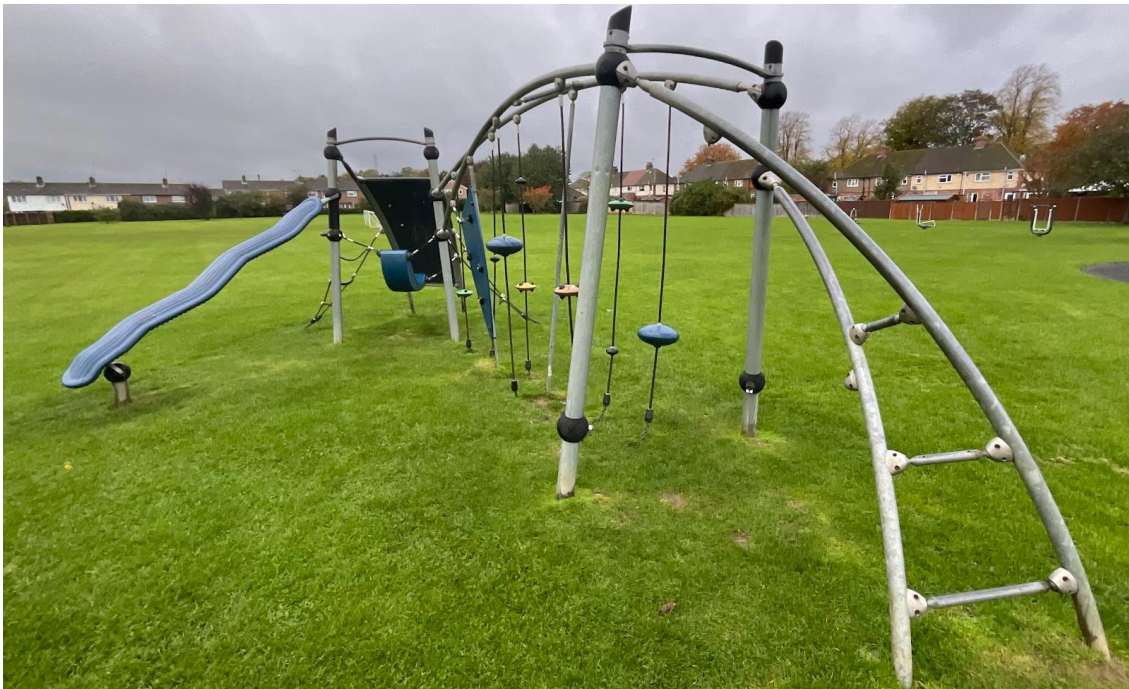
Item of Equipment – Unknown

Findings – This item of equipment has several pieces missing I would presume they have been removed, play value is very limited, I would recommend repairing or replacing with a new item of equipment.

Risk Low

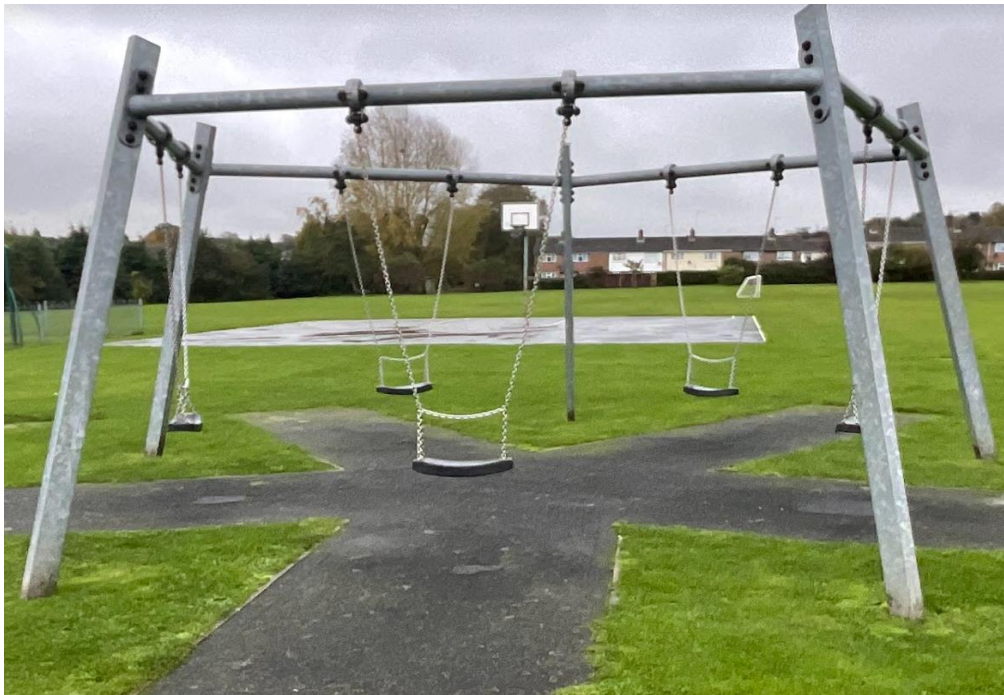
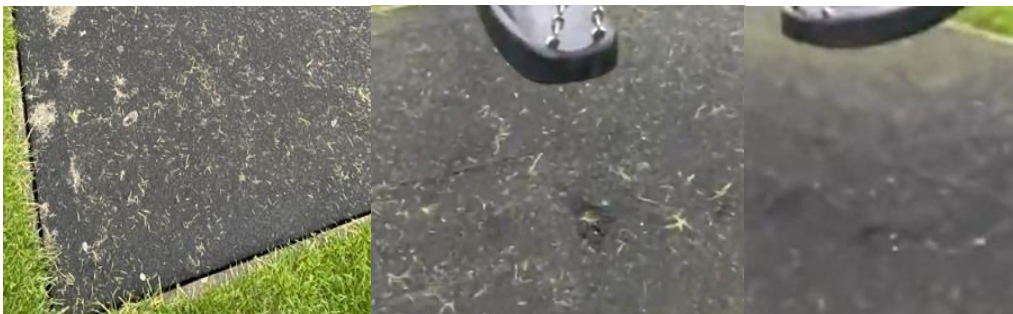
Item of Equipment – 5 Bay Swing

Findings – Rubber Wetpour safety surface is starting to separate from outer edge and wear under two of the swings

Risk Very Low

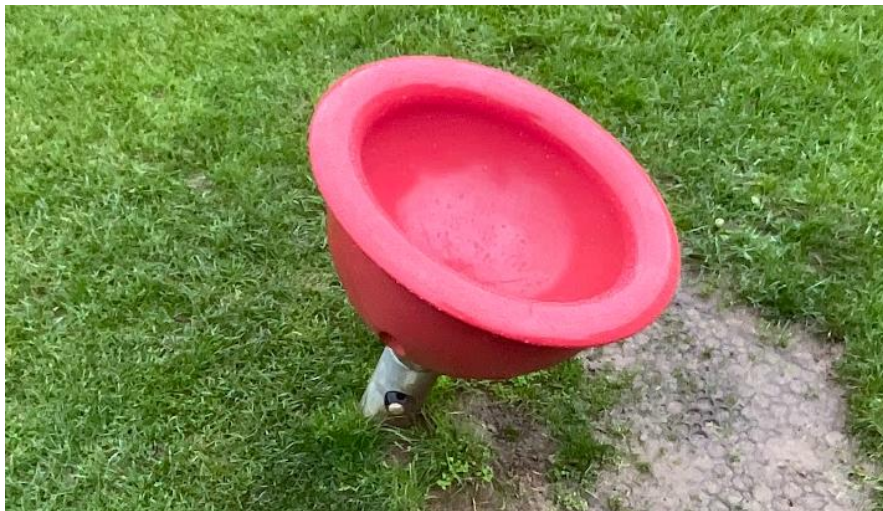
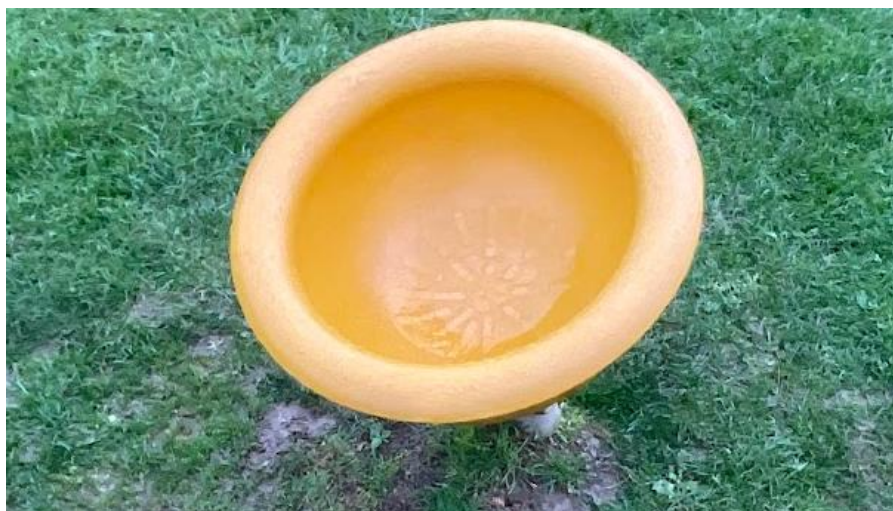
Item of Equipment – Rotating Bowls

Findings – Slight noise from bearing on red bowl

Risk Very Low

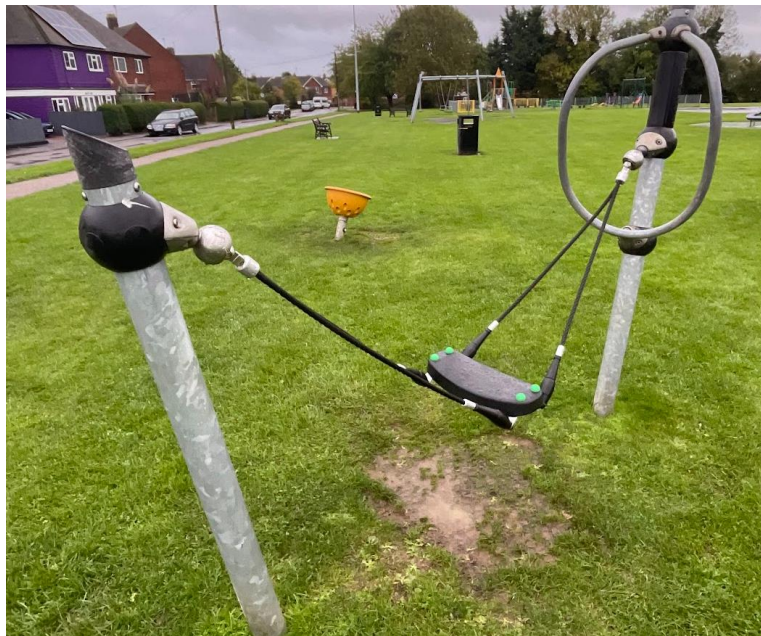
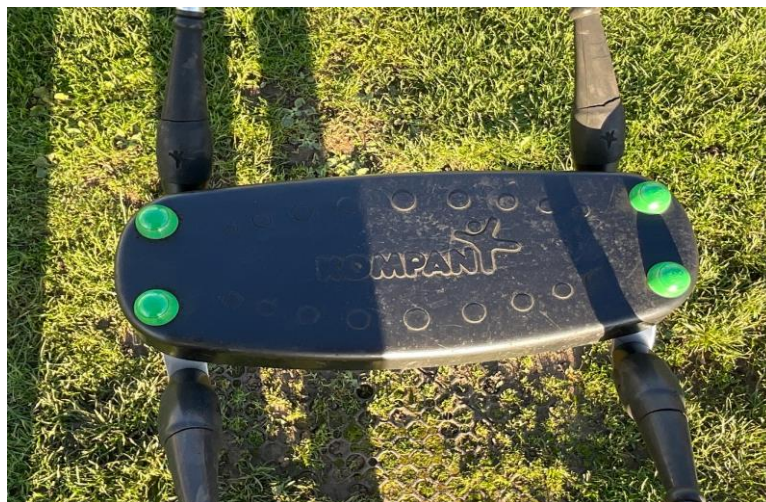
Item of Equipment – Balance Swing

Findings – All four rubber seat connectors are cracked

Risk Low

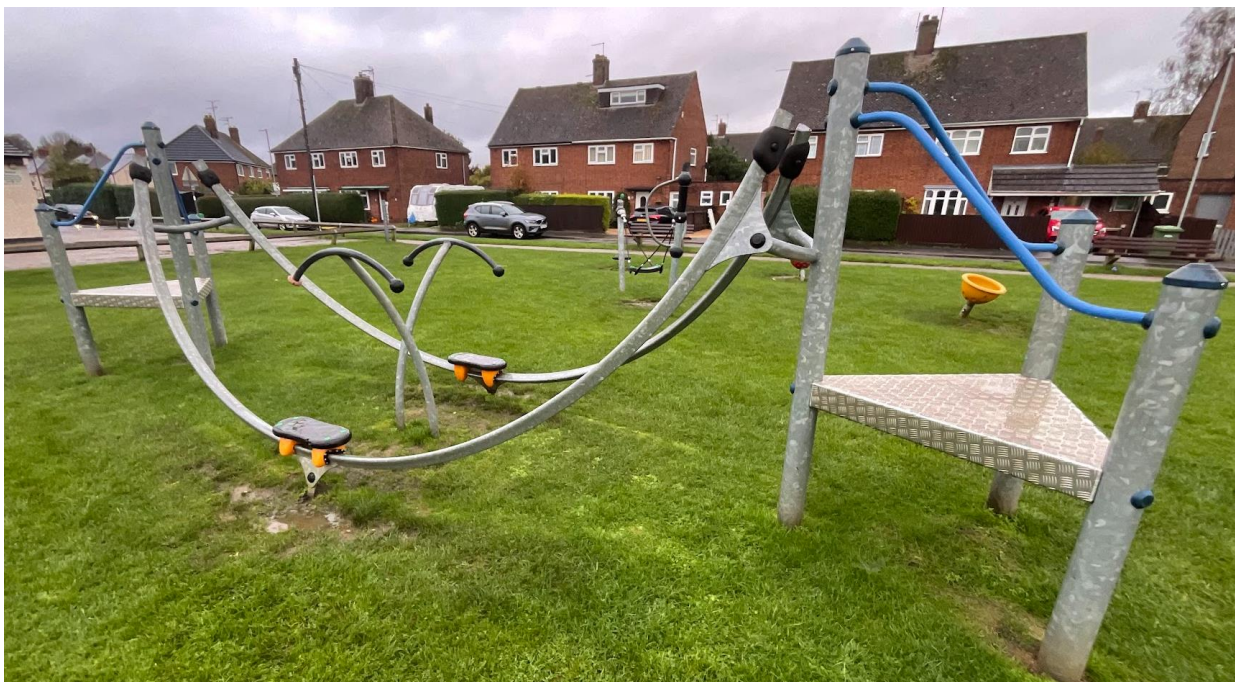
Item of Equipment – Skate Unit

Findings – Slight play in blue hand rail monitor / bearings showing signs of wear on foot plates monitor

Risk Low

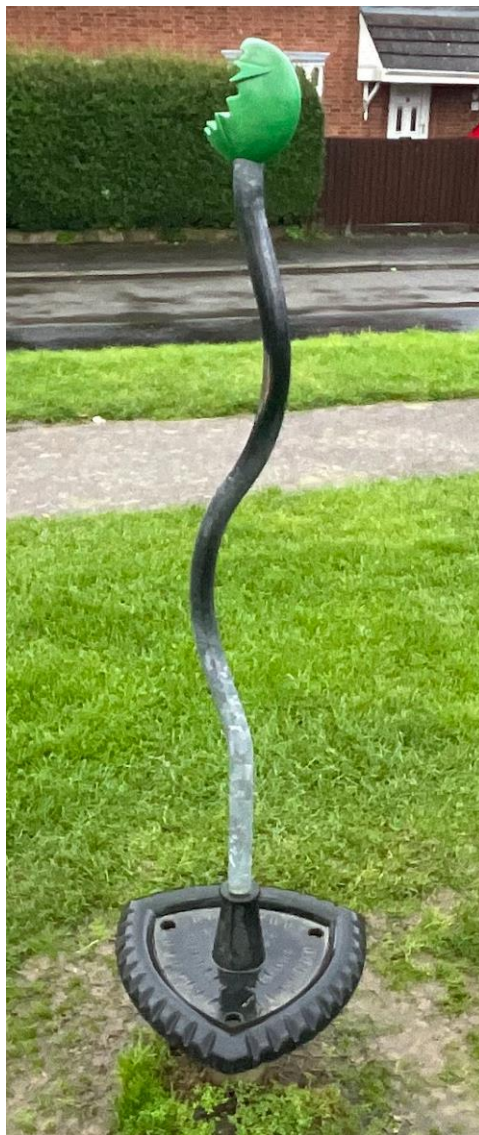
Item of Equipment – Spinning Pole

Findings – Very stiff virtually impossible to turn. I would recommend repairing as it has virtually no play value at the moment

Risk Low

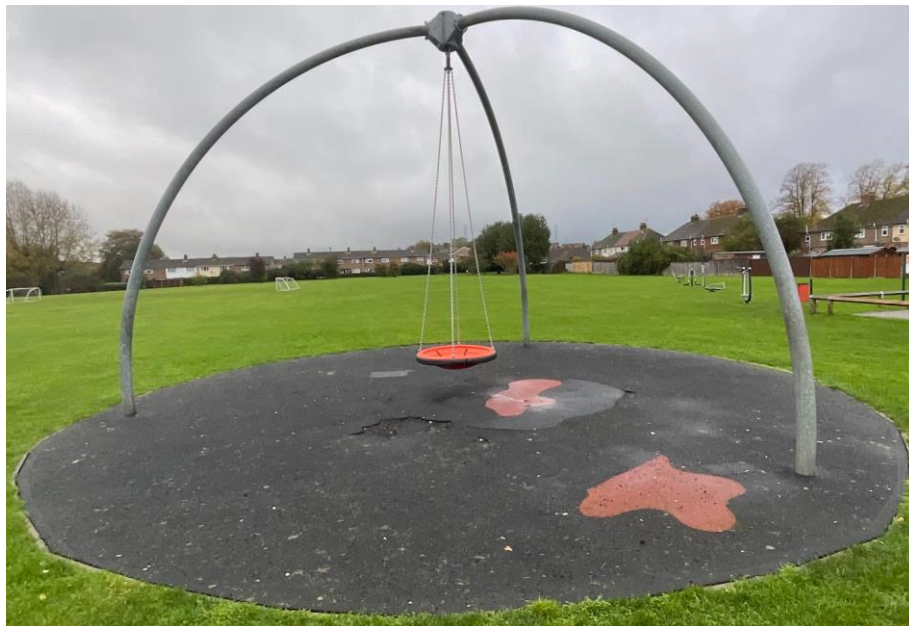
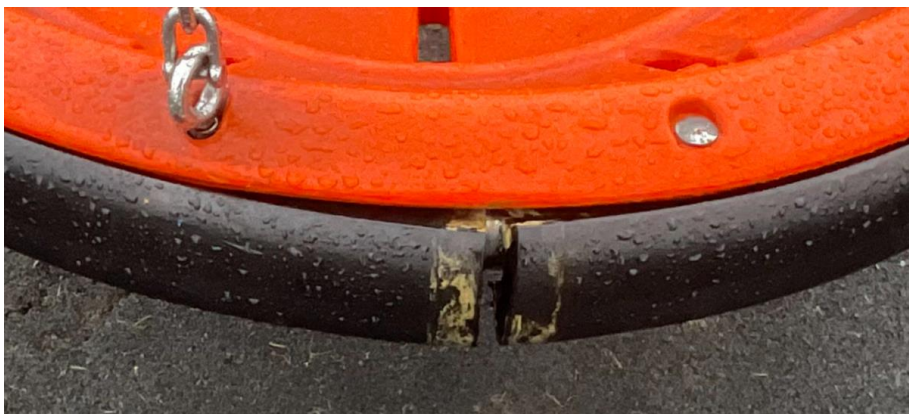
Item of Equipment – Single Point Swing

Findings – Group safety surface has deteriorated due to wear and tear plus vandalism needs monitor closely / the split on the rubber edge has increased in size and now is a potential finger trap

Moderate Risk

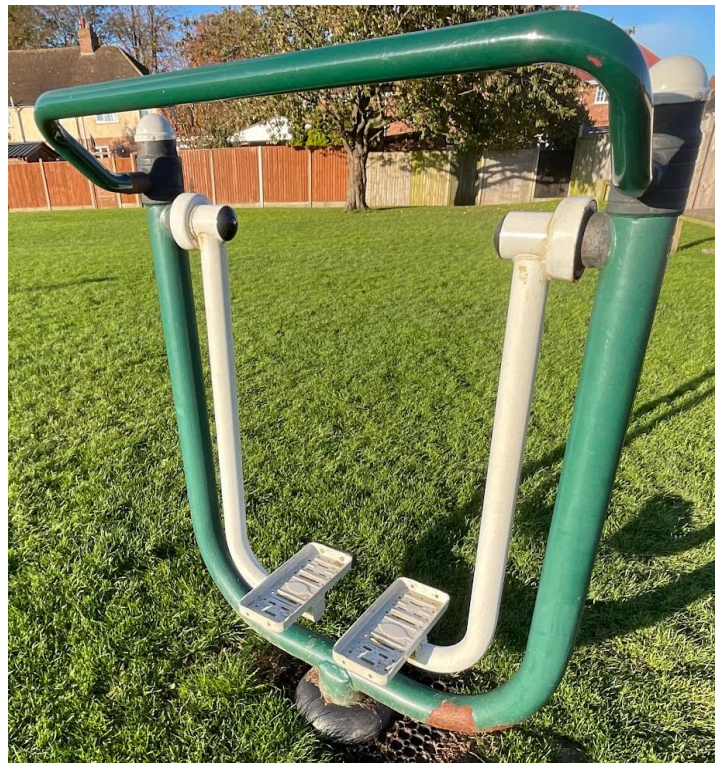
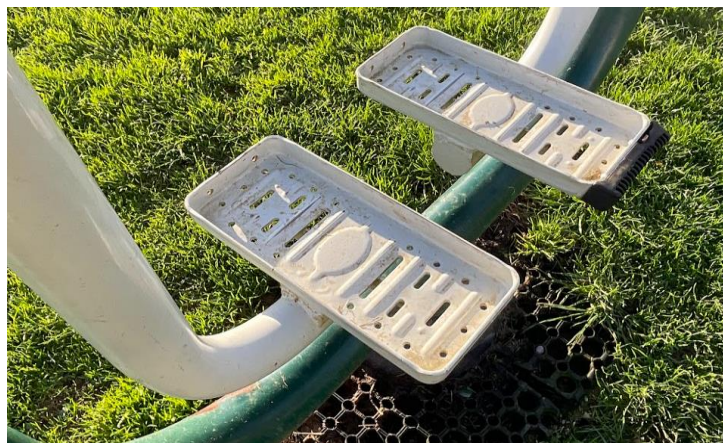
Item of Equipment – Air Walker

Findings – Signs of wear and tear, and corrosion, rubber missing on foot plate

Risk Very Low

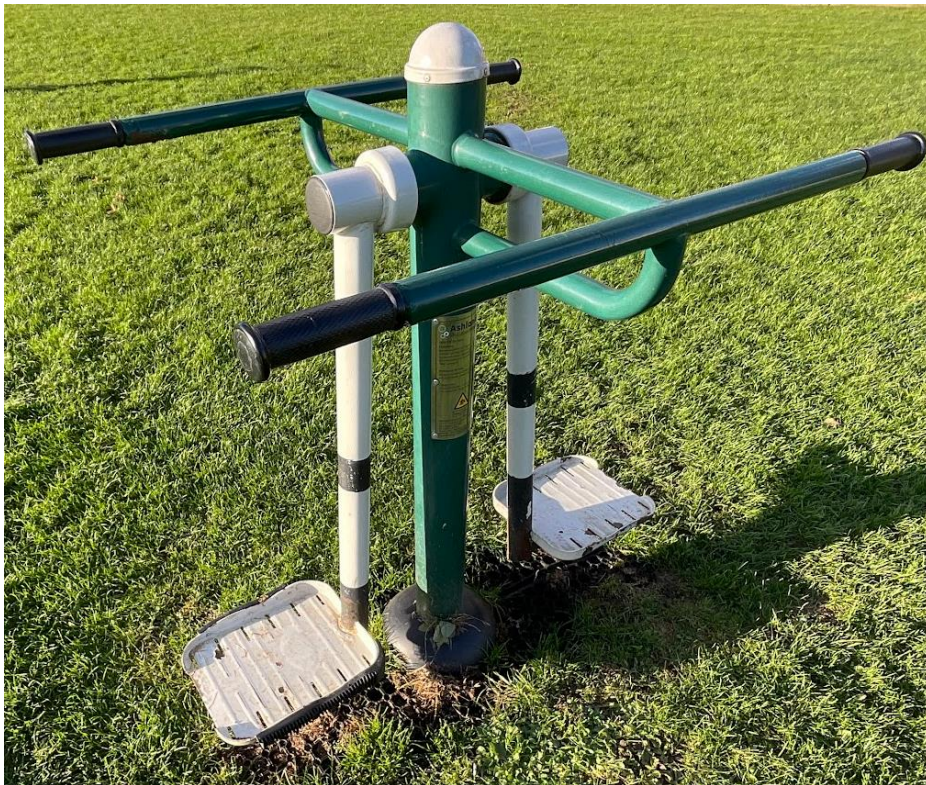
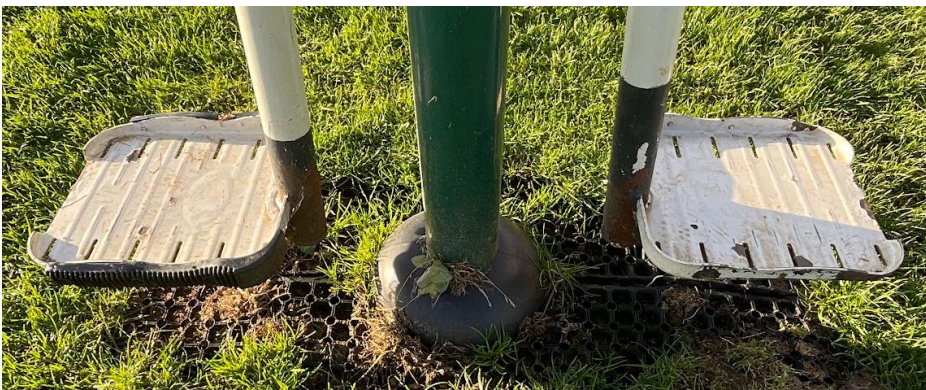
Item of Equipment – Cross Trainer

Findings – Signs of wear and tear, and corrosion, rubbers missing on foot plate monitor for deterioration

Risk Very Low

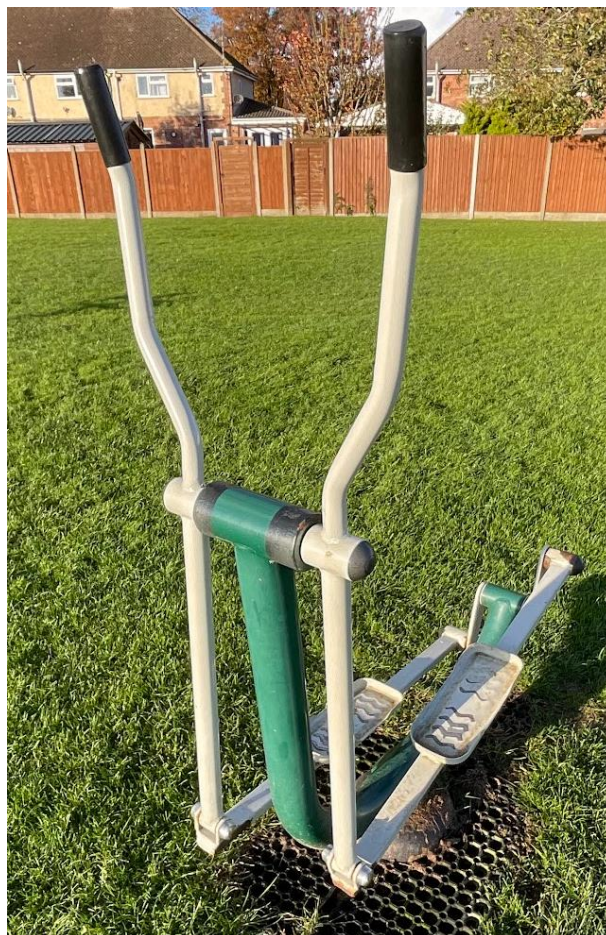
Item of Equipment – Air Skier

Findings – Signs of wear and tear, and corrosion monitor for deterioration

Risk Very Low

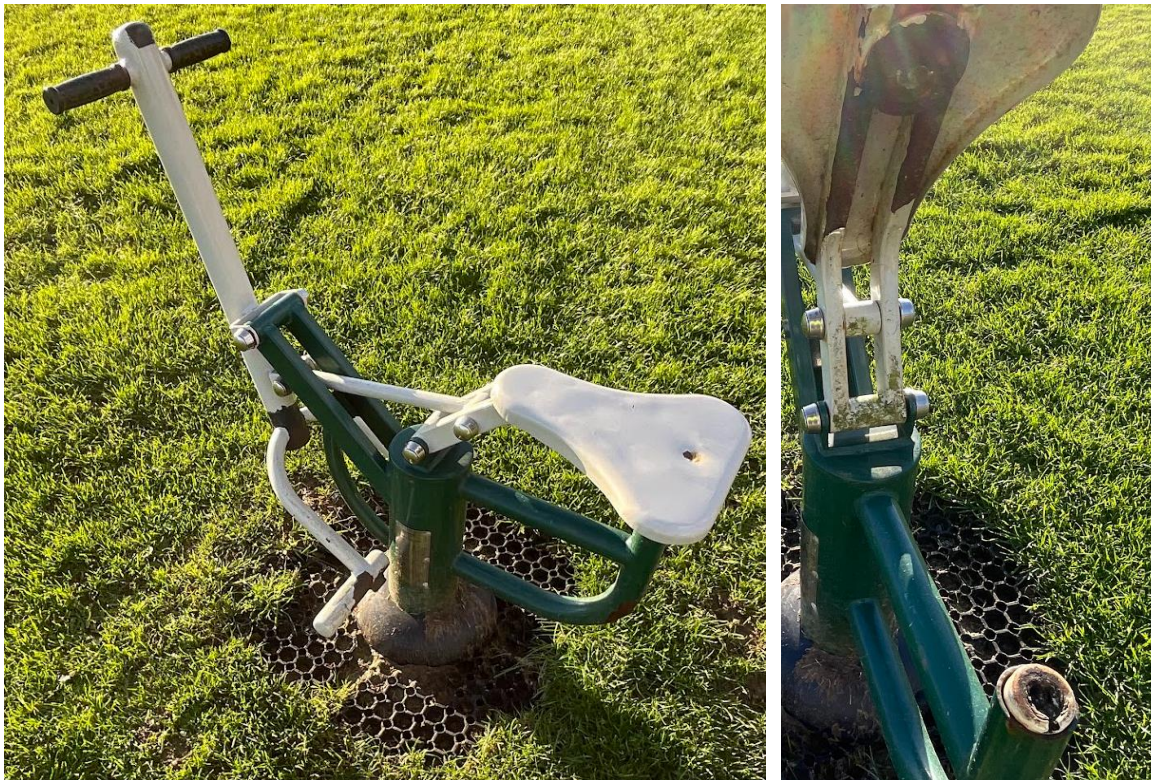
Item of Equipment – Horse Rider

Findings – Signs of wear and tear, corrosion. Rubber stop missing exposing bolt under seat, recommend repairing

Moderate Risk
