## Play Area Safety Inspection Report – Operational Oakham Town Council – Princess Avenue Fenced In Play Area

The inspection was carried out by Iain Mantle – RPII Certified Operational  
Playground Inspector OP8020 - Date of Inspection 12<sup>th</sup> August 2024

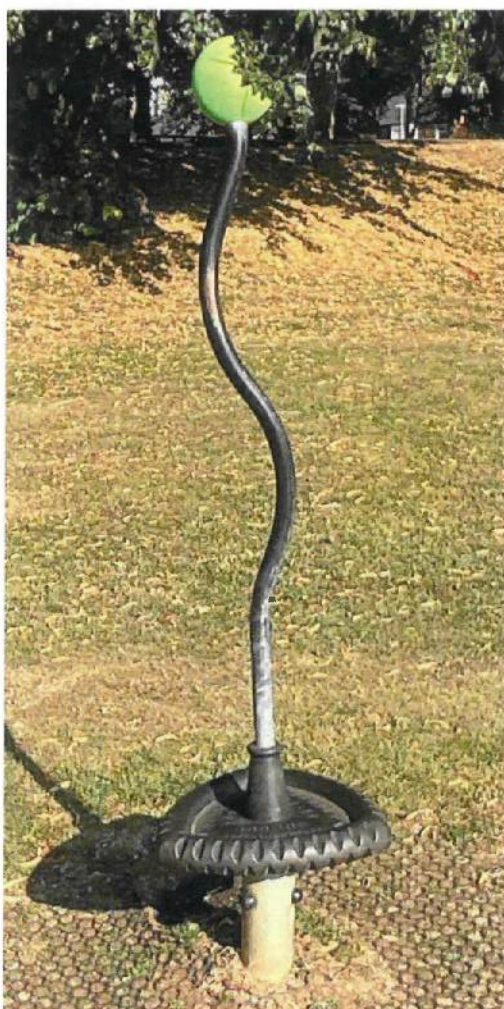
**Item of Equipment- Spinning Pole**

**Findings – This unit now has excessive play in the bearing, will not move freely, very little play value.**

**Recommendations – Replace bearing as soon as possible.**

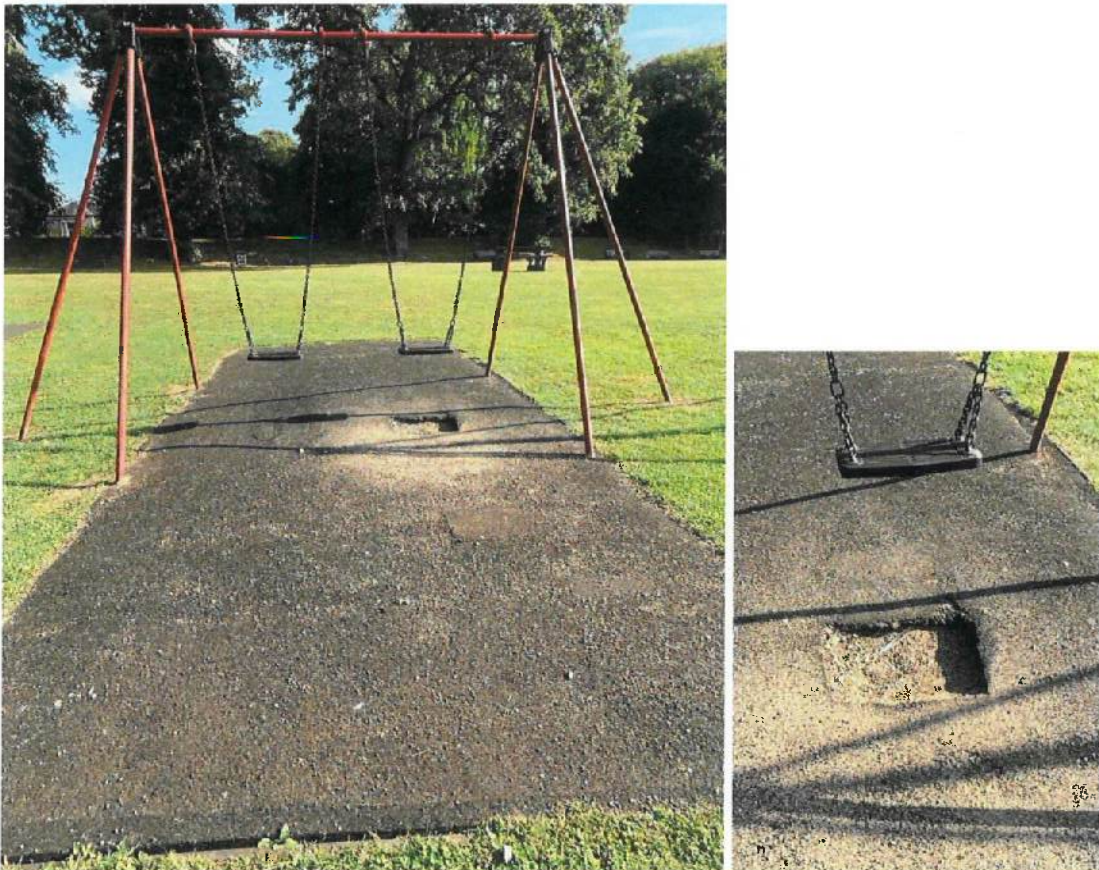
**Findings – Rubber wetpour safety surface shrinking away from timber edge, hole in safety surface exposing a trip hazard and loose stone.**

**Recommendations – Wetpour repair as soon as possible – consider complete wetpour replacement.**

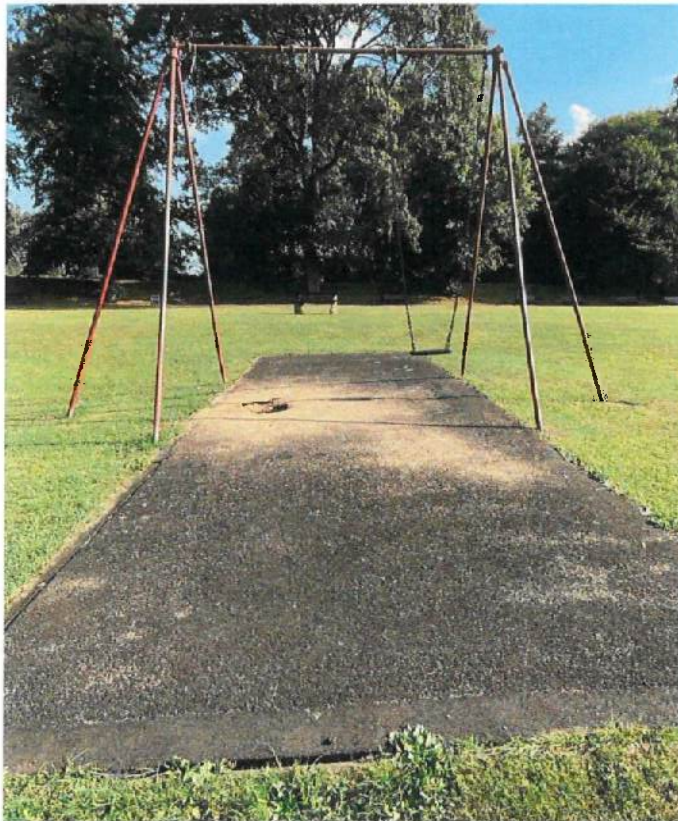
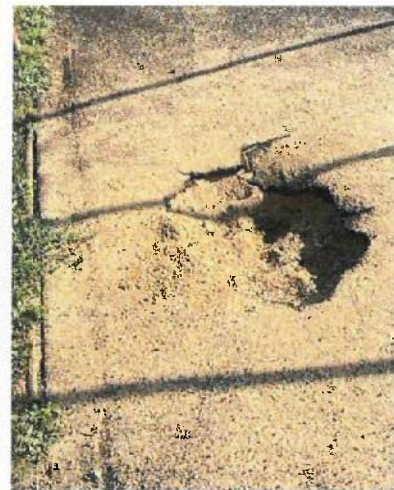
**Item of Equipment-2 Bay 2 Flat Swings**

**Findings – Rubber wetpour safety surface shrinking away from timber edge, hole in safety surface exposing a trip hazard and loose stone sub base.**

**Recommendations – Wetpour repair as soon as possible – consider complete wetpour replacement.**

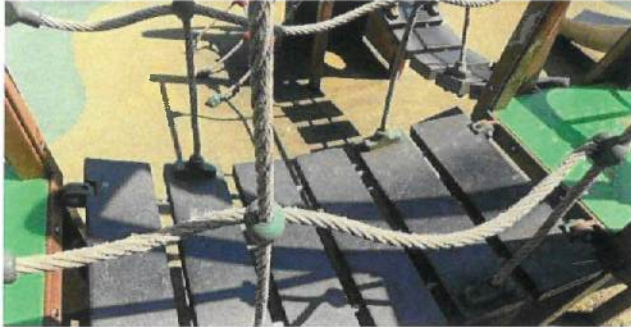
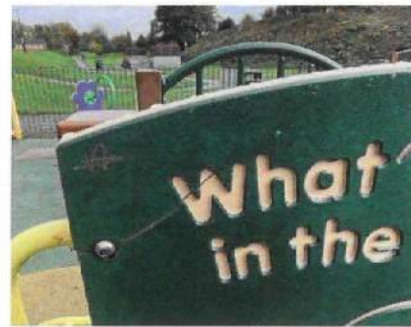
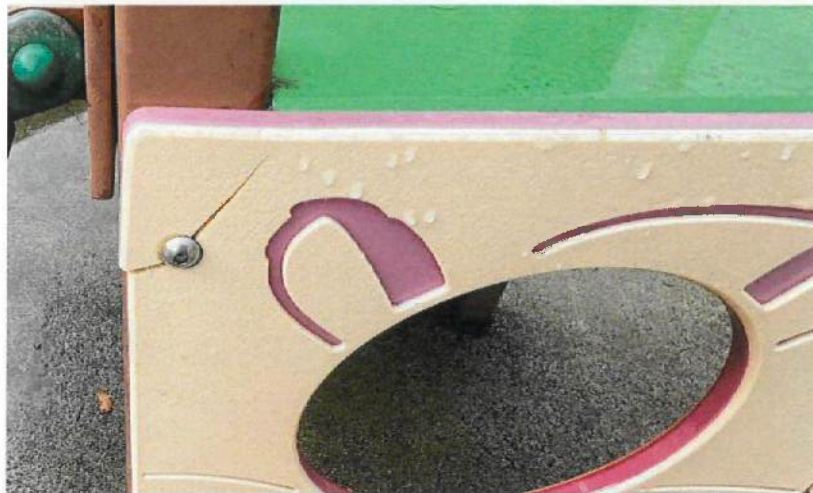
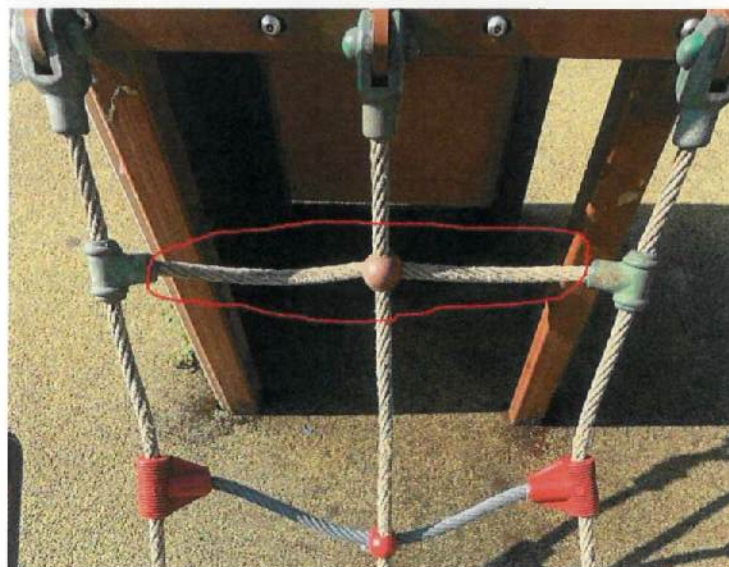
Inner wire now exposed on ladder and bridge, recommend rope repair for both

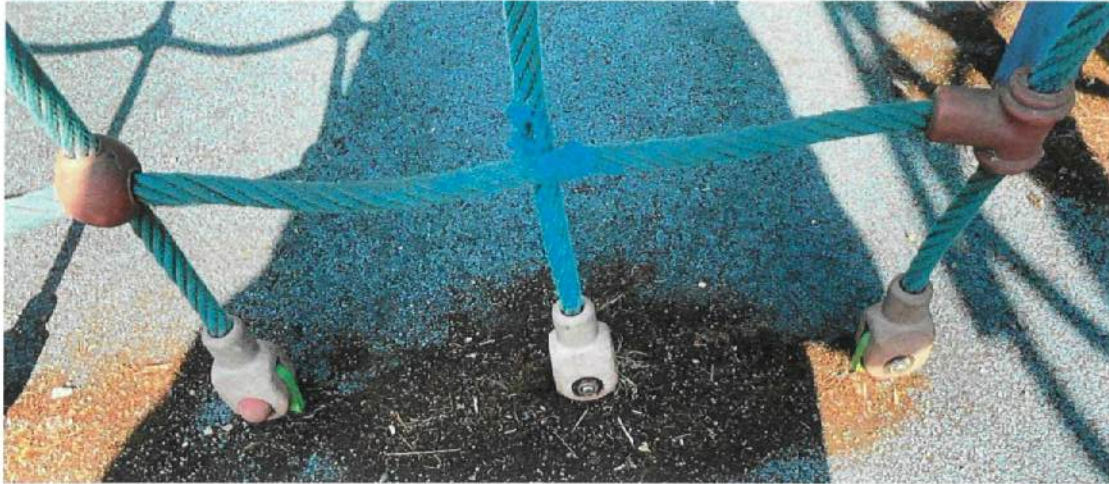
**Two small plastics missing**

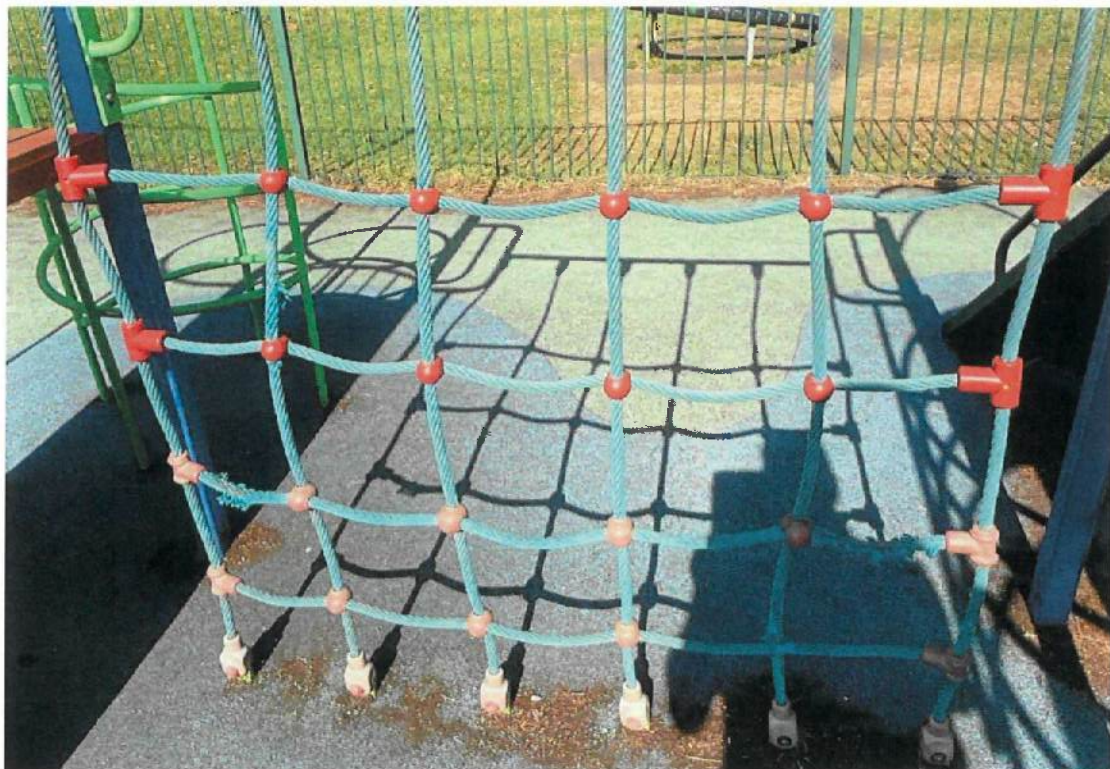
**Sections of the rope cargo net showing exposed inner wires**

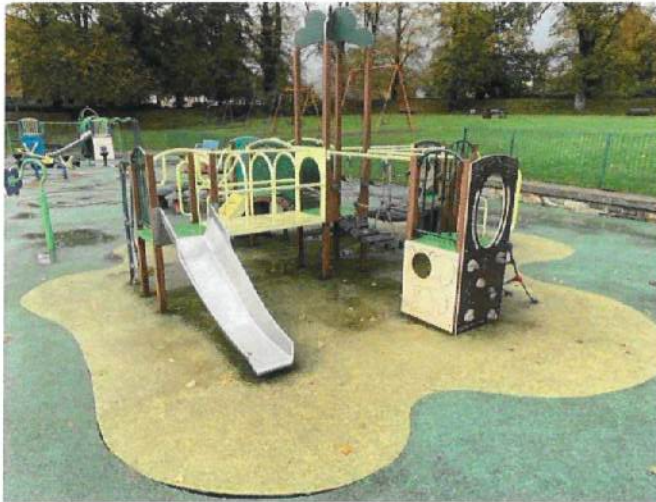
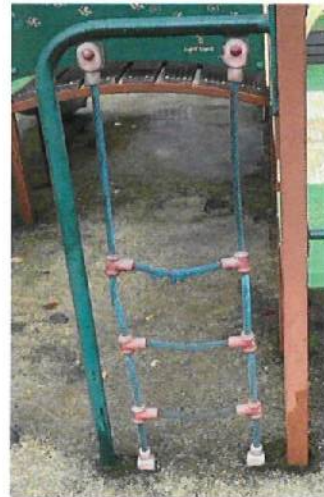
**Item of Equipment- Toddler Multi-Play Unit**

**Findings – Split on two of the play panels. Substantial wear on the rope nets. Shrinkage on rubber wetpour surface potential trip hazard.**

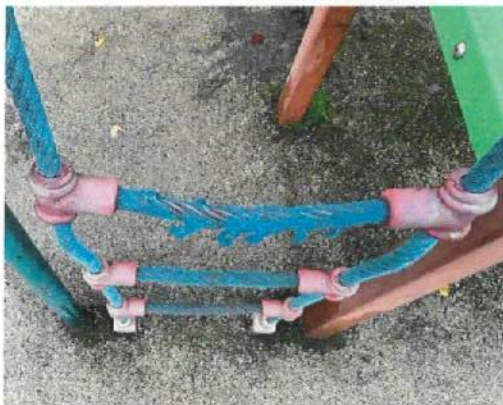
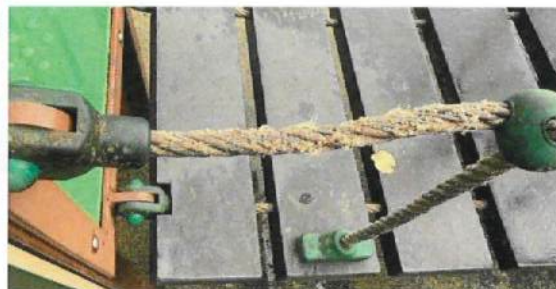
**Inner wire now exposed on ladder and bridge, recommend rope repair for both**

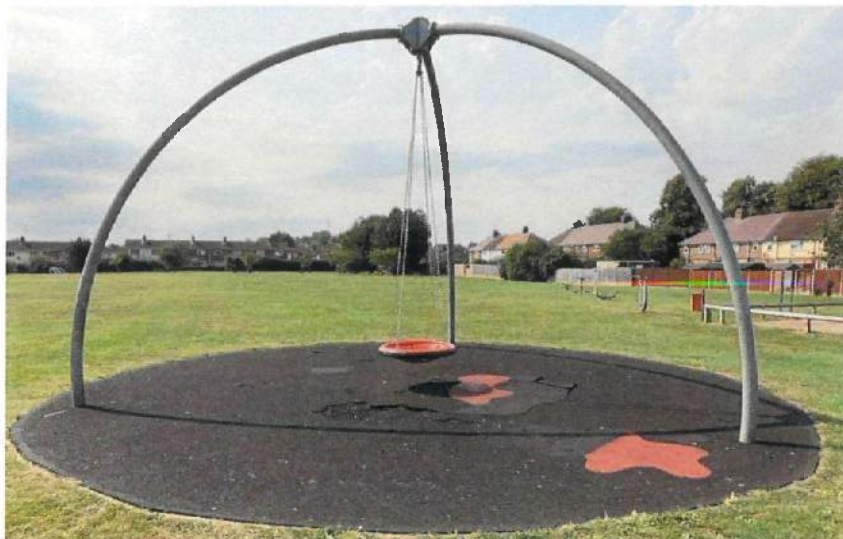
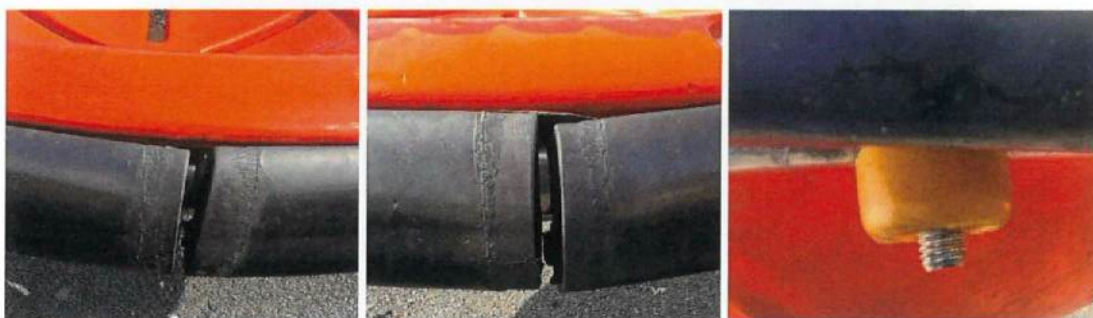
**Item of Equipment – Single Point Swing**

**Findings – Group safety surface has deteriorated due to wear and tear plus vandalism needs repairing, basket seat bands missing on both sides, gaps have increased in size and now is a potential finger trap.**

**Three plastic caps are now missing from the underside of basket swing these need replacing**

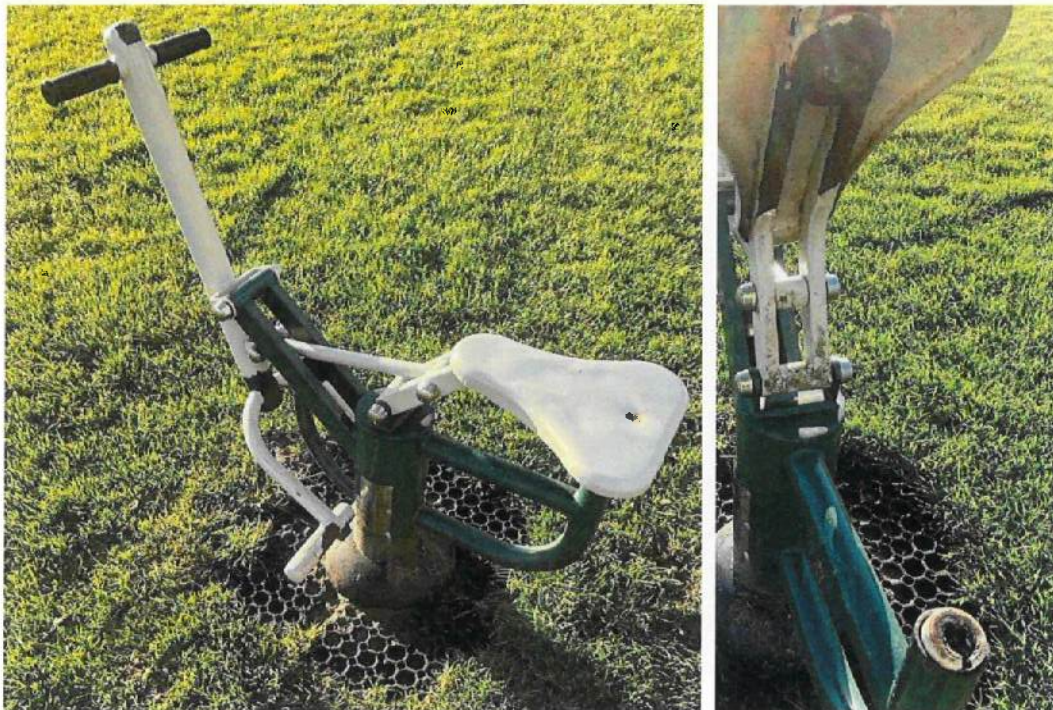
**Item of Equipment – Horse Rider**

**Findings – Signs of wear and tear, corrosion. Rubber stop missing exposing bolt under seat, recommend repairing**

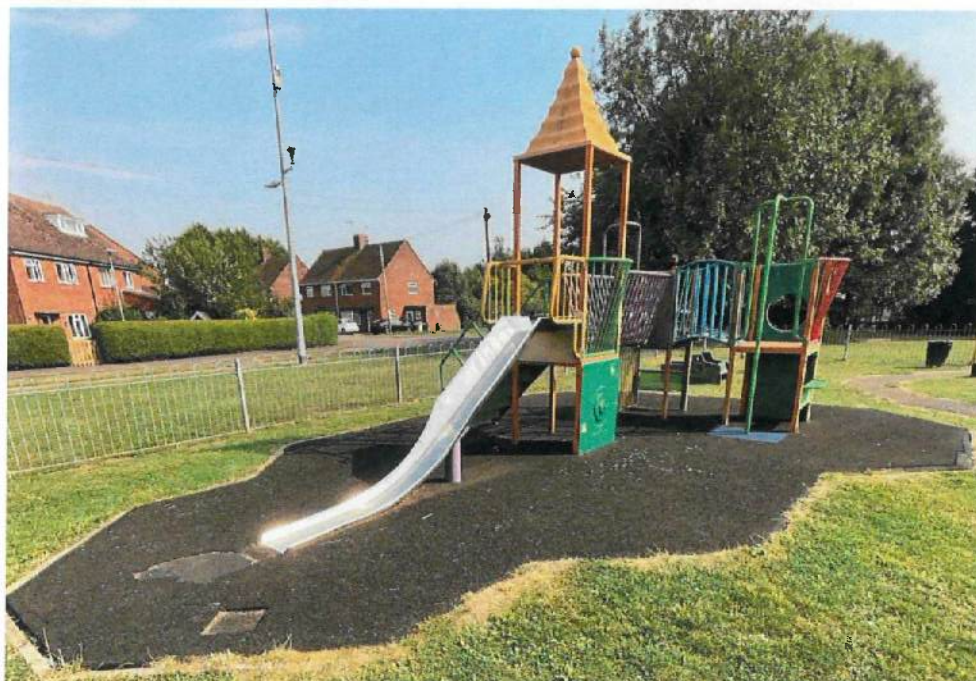
### Item of Equipment-Multiplay Unit

Findings – Rubber Wetpour safety surface very slippery also wearing at the bottom of slide. There is shrinkage, separation from concrete edge, also the Wetpour is raised at the edge creating a trip hazard. Recommend repairing

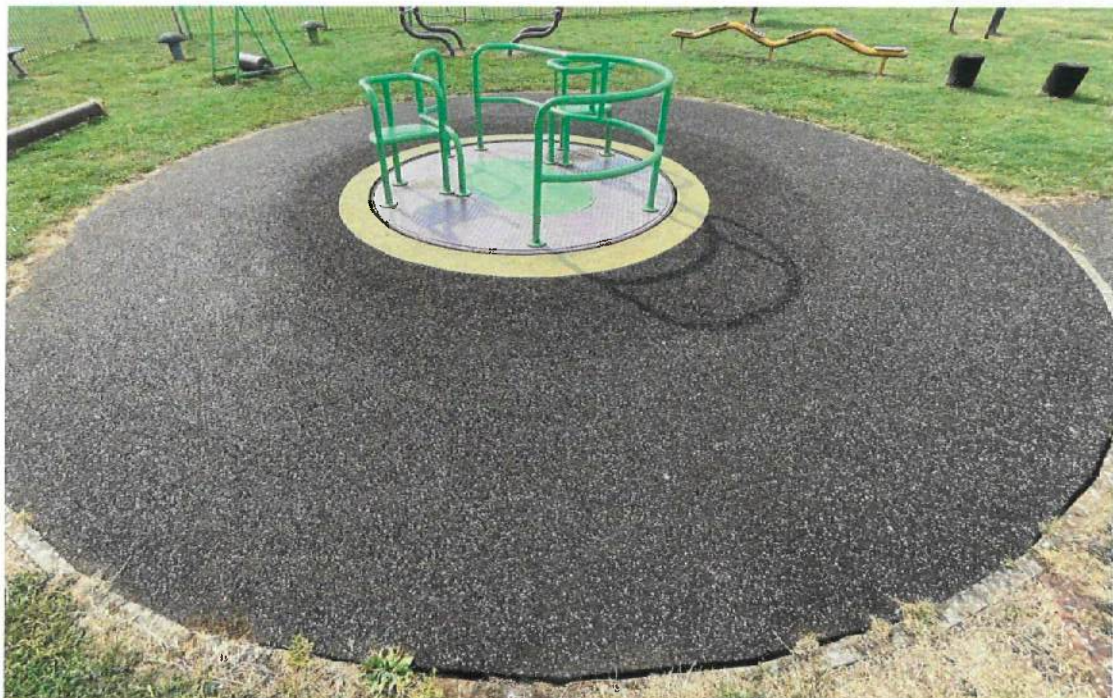
**Item of Equipment- Inclusive Roundabout**

**Findings – Roundabout is now almost impossible to turn reducing the play value.  
Requires immediate attention.**

**Wetpour is showing signs of separation around outer edge adjacent to the concrete,  
and the wetpour edge directly next to the roundabout now has gap, potential finger  
trap.**

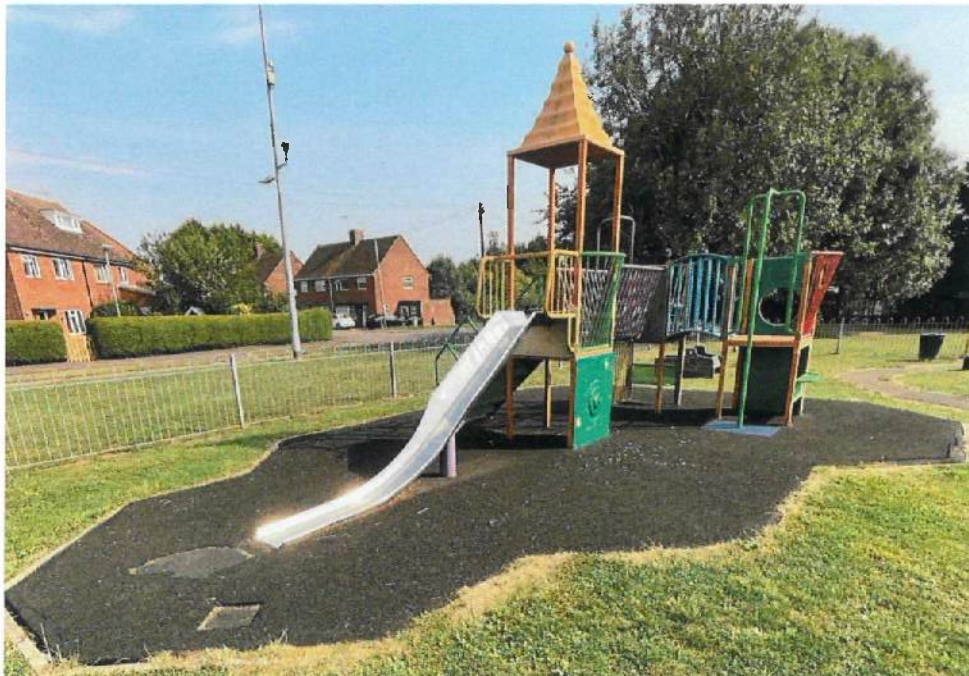
**Item of Equipment-Multiplay Unit**

**Findings – Rubber Wetpour safety surface very slippery also wearing at the bottom of slide. There is shrinkage, separation from concrete edge, also the Wetpour is raised at the edge creating a trip hazard. Recommend repairing**

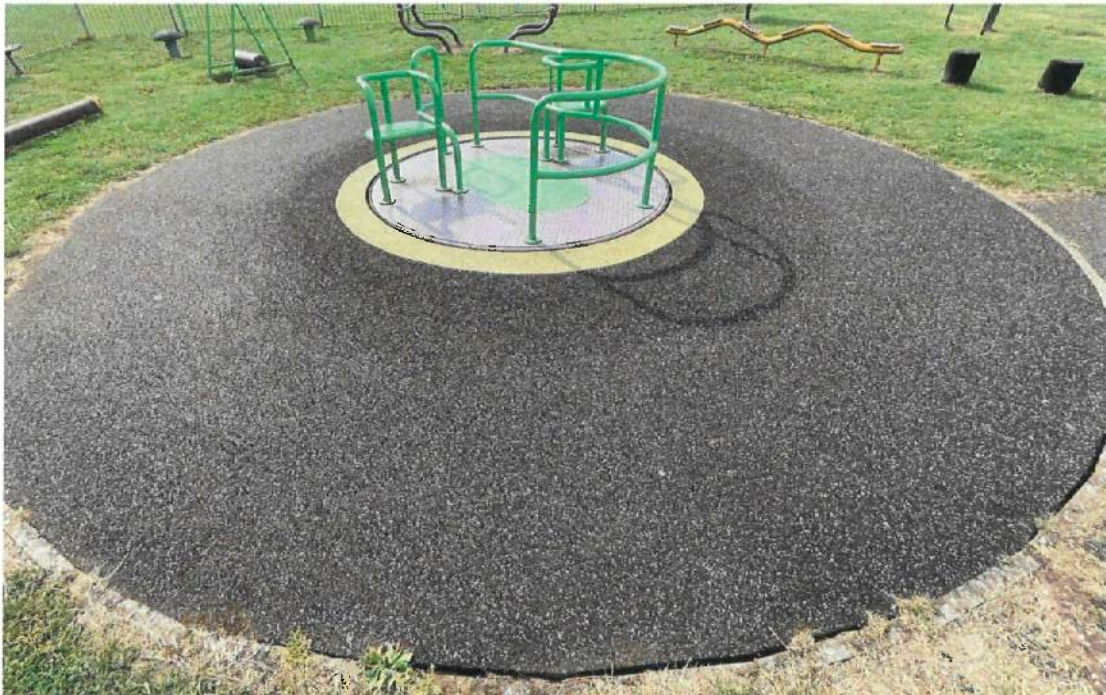
**Item of Equipment- Inclusive Roundabout**

**Findings – Roundabout is now almost impossible to turn reducing the play value.  
Requires immediate attention.**

**Wetpour is showing signs of separation around outer edge adjacent to the concrete,  
and the wetpour edge directly next to the roundabout now has gap, potential finger  
trap.**

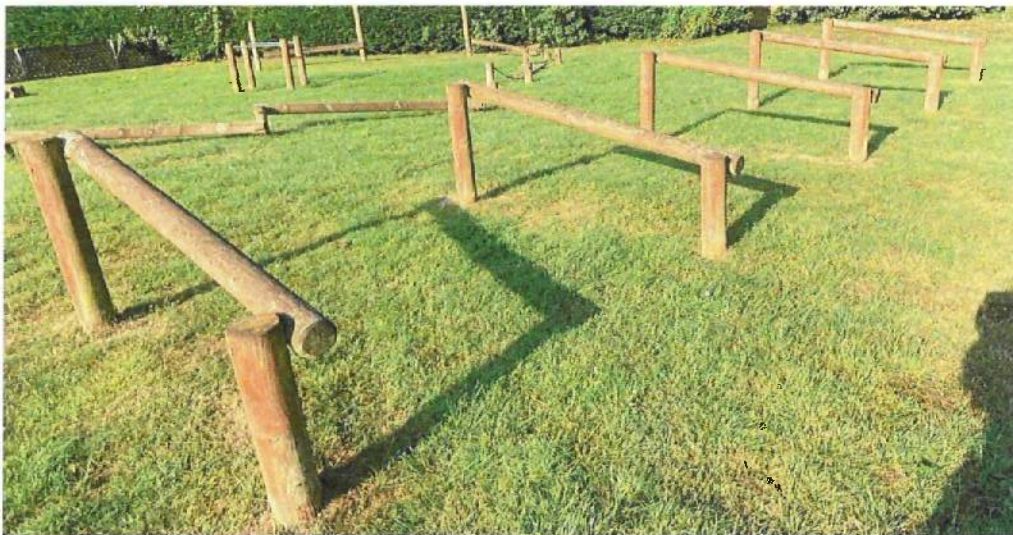
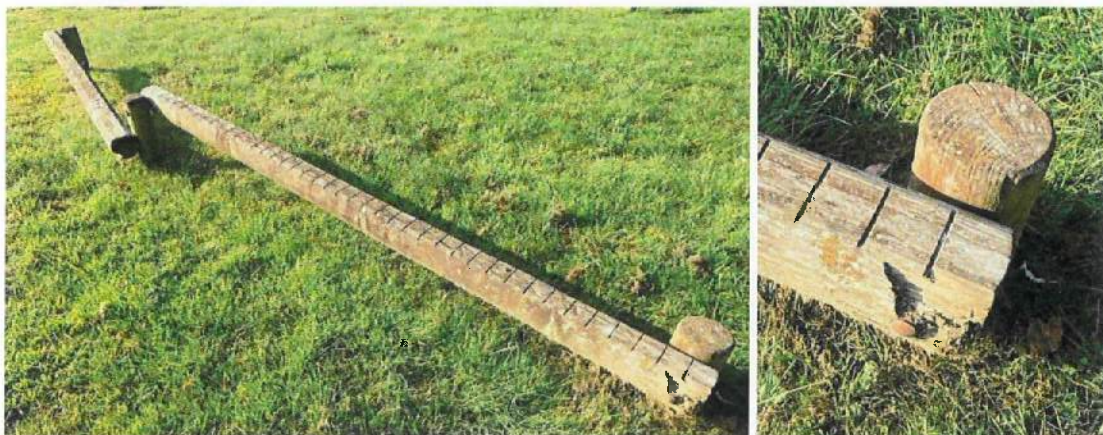
**Item of Equipment-Timber Trim Trail**

**Findings – Many parts of the trim trail are showing signs of wear and tear, timbers are rotting and need replacing as soon as possible please see photos. Strimmer damage on all timbers. (Please see other notes below)**

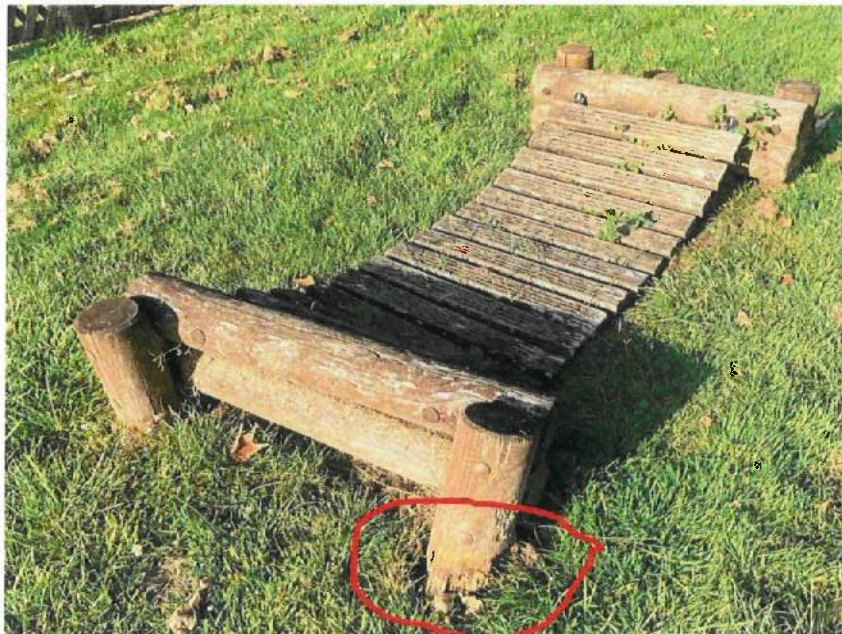
**Timber bridge support leg has failed requires replacing**

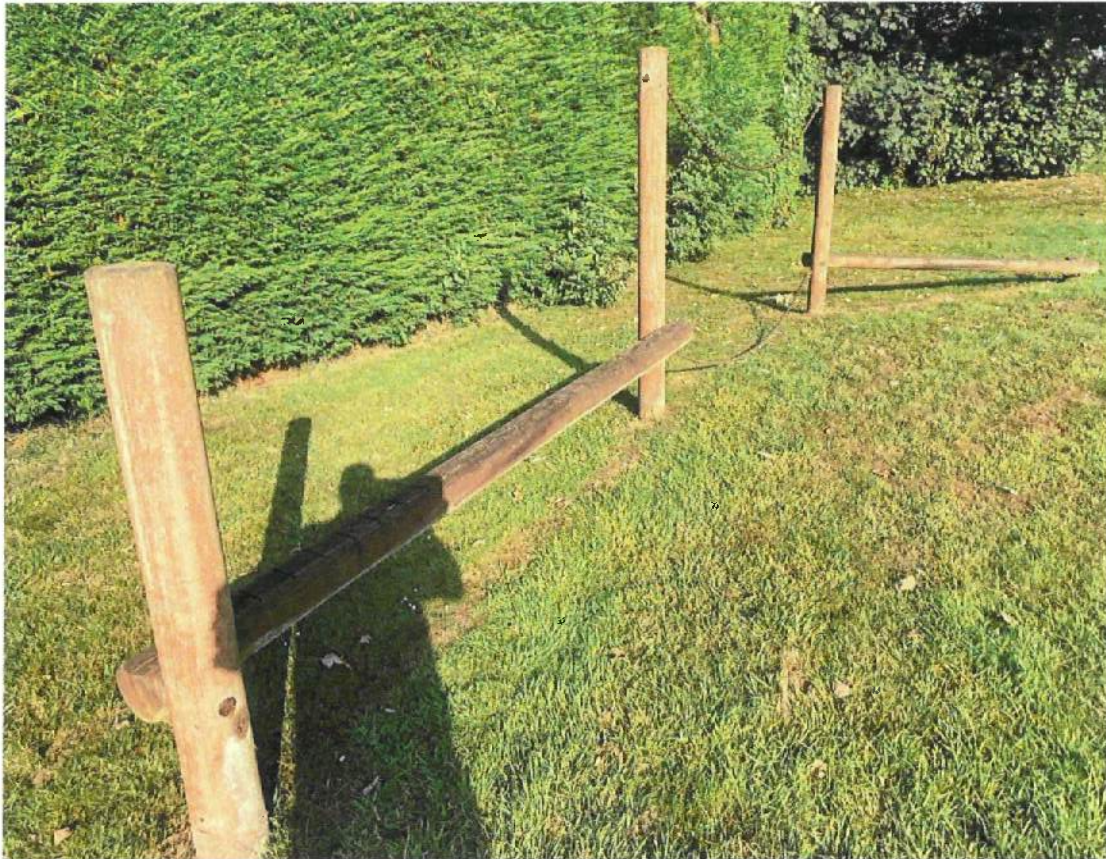
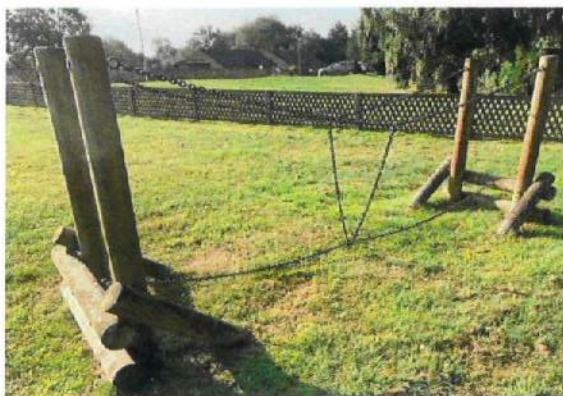
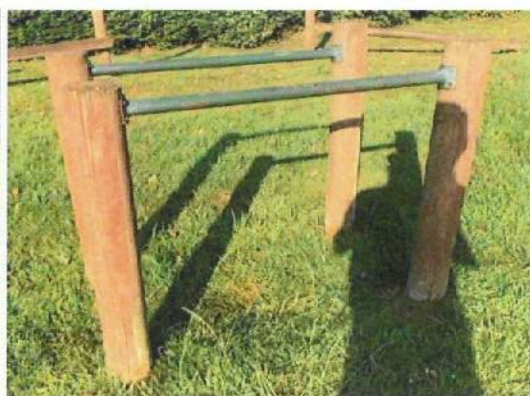
**Strimmer damage, splits and rot on balance beams.**
