Annual Inspection Report

Cutts Close Play Area

Client:	Oakham Town Council
Address:	Rol House, Long Row, Oakham, Rutland, LE15 6LN
Date:	27th November 2025
Inspector:	Jamie Haynes

Assessed site risk at time of inspection
Play Area - Medium Risk (10)
Skate Park - High Risk (15)

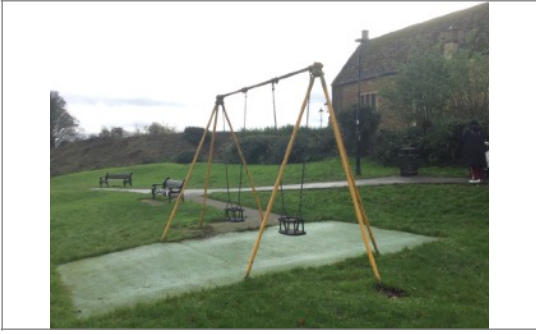
Item	1 Bay 2 Cradle Swings (1 of 2)				
Supplier	Wicksteed				
Surface	Wet Pour				
Risk Rating Overall	Very Low	Low	Medium	High	Unacceptable
			8

Chain/connecting link(s) wear evident. Recommendation: Monitor to replace at 40% dia wear.	8

Slight damage evident to seats. Recommendation: Monitor this condition.	5

Missing plastic cap(s) evident. Recommendation: Replace missing cap(s)	7

Rust/corrosion evident to framework. Recommendation: Monitor for deterioration.	8

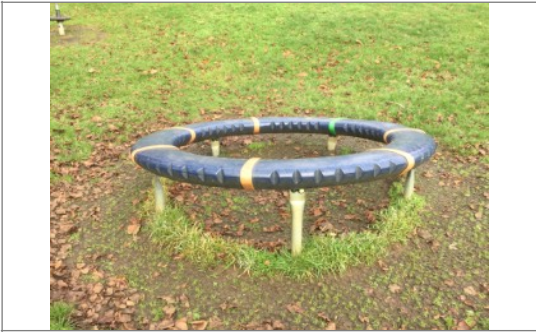
Item	Supernova				
Supplier	Kompan				
Surface	Grass Matting				
Risk Rating Overall	Very Low	Low	Medium	High	Unacceptable
		7

Damage evident to surfacing. Recommendation: Replace damaged surfacing.	7
	Recommendation:	
	Recommendation:	
	Recommendation:

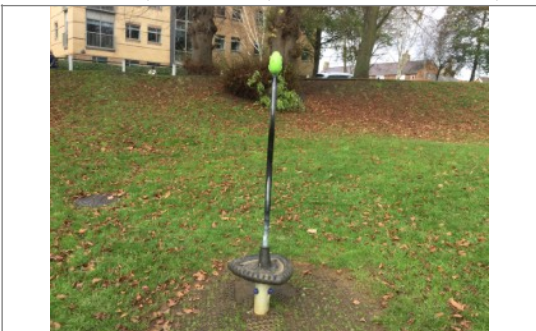
Item	Spinning Pole				
Supplier	Kompan				
Surface	Grass Matting				
Risk Rating Overall	Very Low	Low	Medium	High	Unacceptable
		7

Damage evident to surfacing. Recommendation: Replace damaged surfacing.	7

Wear evident to bearing. Recommendation: Replace worn bearing.	7
	Recommendation:	
	Recommendation:

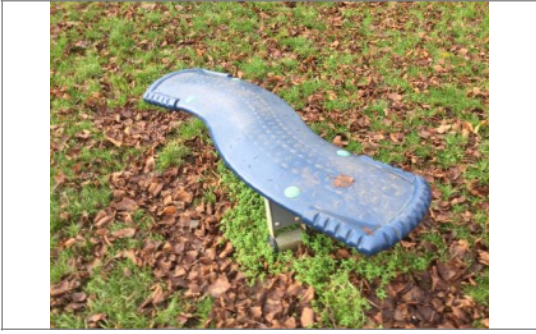
Item	Balance Board				
Supplier	Kompan				
Surface	Grass Matting				
Risk Rating Overall	Very Low	Low	Medium	High	Unacceptable
		5

No faults found during the inspection.

Recommendation:
No action required, monitor this item.

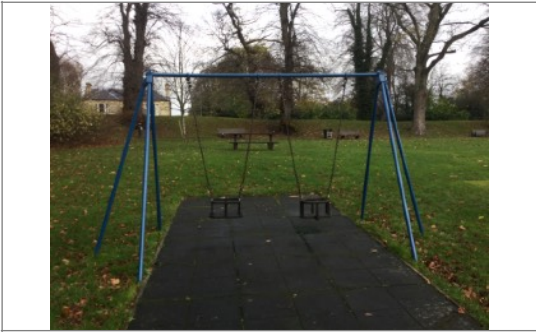
Item	1 Bay 2 Cradle Swing (2 of 2)				
Supplier	Wicksteed				
Surface	Rubber Tiles				
Risk Rating Overall	Very Low	Low	Medium	High	Unacceptable
			8

Gaps evident in rubber tiles.

Chain/connecting link(s) wear evident.

Recommendation:
Monitor to repair this condition.

Recommendation:
Monitor to replace at 40% dia wear.

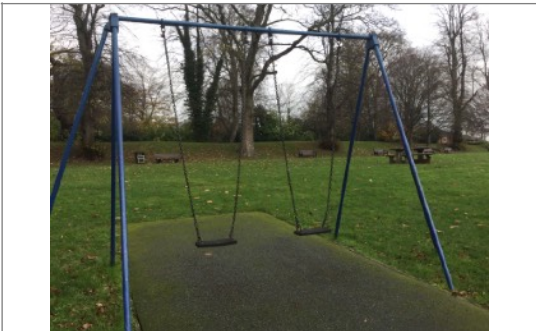
Item	1 Bay 2 Flat Swing (1 of 3)				
Supplier	Wicksteed				
Surface	Wet Pour				
Risk Rating Overall	Very Low	Low	Medium	High	Unacceptable
			8

Wet pour shrinkage in places.

Chain/connecting link(s) wear evident.

Recommendation:
Monitor to repair this condition.

Recommendation:
Monitor to replace at 40% dia wear.

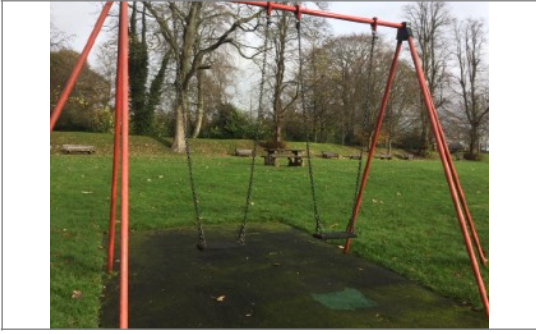
Item	1 Bay 2 Flat Swing (2 of 3)				
Supplier	Wicksteed				
Surface	Wet Pour				
Risk Rating Overall	Very Low	Low	Medium	High	Unacceptable
			8

Wet pour shrinkage in places. Recommendation: Monitor to repair this condition.	7
---	--	----------

Chain/connecting link(s) wear evident. Recommendation: Monitor to replace at 40% dia wear.	8
---	---	----------

As above finding. Recommendation: As above comment.	8
---	--	----------

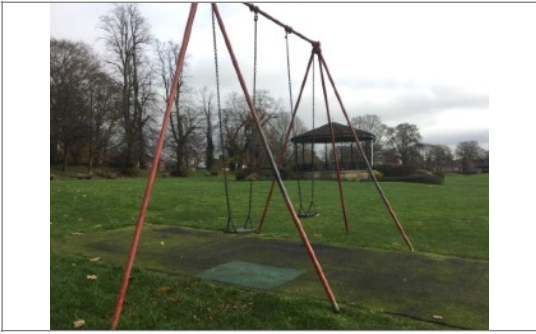
Item	1 Bay 2 Flat Swing (3 of 3)				
Supplier	Wicksteed				
Surface	Wet Pour				
Risk Rating Overall	Very Low	Low	Medium	High	Unacceptable
			8

Wet pour shrinkage in places. Recommendation: Monitor to repair this condition.	7
---	--	----------

Chain/connecting link(s) wear evident. Recommendation: Monitor to replace at 40% dia wear.	8
--	---	----------

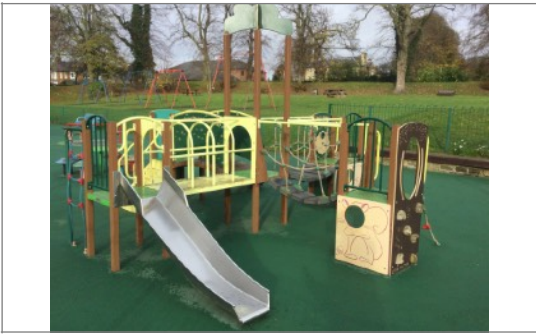
Item	Toddler Multiplay Unit				
Supplier	Park Leisure				
Surface	Wet Pour				
Risk Rating Overall	Very Low	Low	Medium	High	Unacceptable
			10

Rope wear evident exposing metal core. Recommendation: Monitor this condition.	6
---	---	----------

Slight wear evident to bridge rope bearings. Recommendation: Monitor this condition.	7
---	---	----------

Damage evident to multiple panels. Recommendation: Replace damaged panels.	10
---	---	-----------

Missing fixing(s) evident. Recommendation: Replace missing fixing(s).	7
---	--	----------

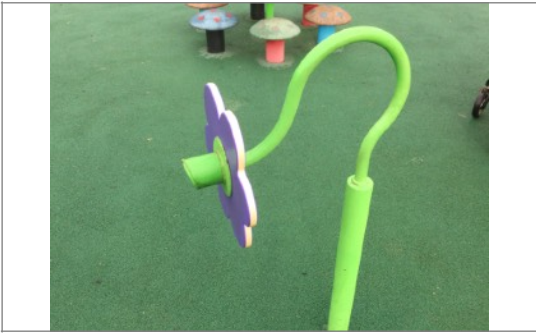
Item	2x Talking Tubes				
Supplier	Park Leisure				
Surface	Wet Pour				
Risk Rating Overall	Very Low	Low	Medium	High	Unacceptable
		4

No faults found during the inspection.
Recommendation:
 No action required, monitor this item.

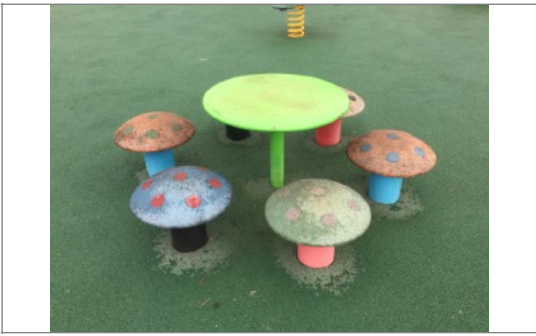
Item	Mushroom Seats & Tables				
Supplier	Park Leisure				
Surface	Wet Pour				
Risk Rating Overall	Very Low	Low	Medium	High	Unacceptable
		4

No faults found during the inspection.
Recommendation:
 No action required, monitor this item.

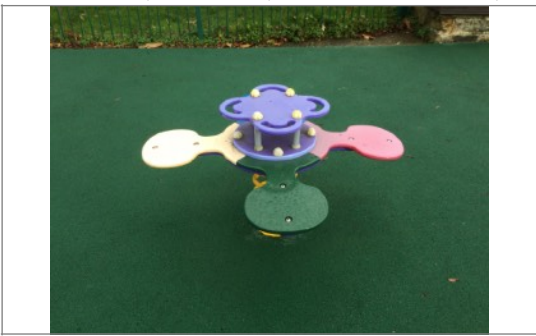
Item	4 Way Springer				
Supplier	Park Leisure				
Surface	Wet Pour				
Risk Rating Overall	Very Low	Low	Medium	High	Unacceptable
		5

Missing plastic cap(s) evident.
Recommendation:
 Replace missing plastic cap(s).

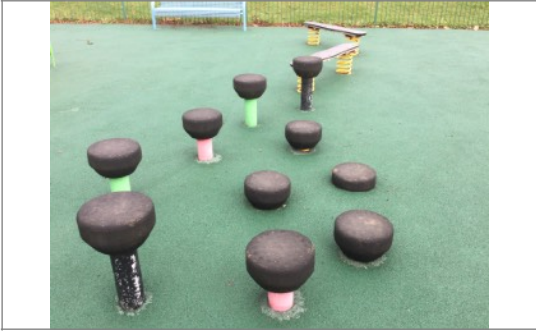
Item	Step Links & Wobble Boards				
Supplier	Park Leisure				
Surface	Wet Pour				
Risk Rating Overall	Very Low	Low	Medium	High	Unacceptable
		6

1x link loose in ground fixing. Recommendation: Monitor to repair this condition.	6
---	--	----------

Missing plastic cap(s) evident. Recommendation: Replace missing plastic cap(s).	5
---	--	----------

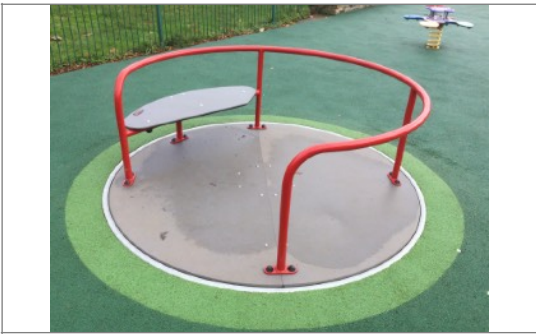
Item	Inclusive Roundabout				
Supplier	Kompan				
Surface	Wet Pour				
Risk Rating Overall	Very Low	Low	Medium	High	Unacceptable
			8

This type of unit is known to move slightly over time causing possible finger traps. Recommendation: Monitor edge of unit for gaps larger than 8mm and carry out remedial work as required.	8
---	--	----------

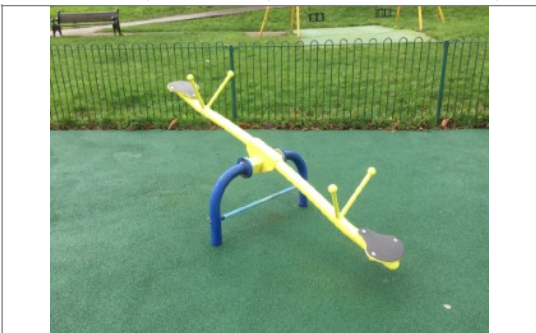
Item	Seesaw				
Supplier	Park Leisure				
Surface	Wet Pour				
Risk Rating Overall	Very Low	Low	Medium	High	Unacceptable
		7

Wearing evident to pivot block. Recommendation: Monitor this condition, replace as required.	7
---	---	----------

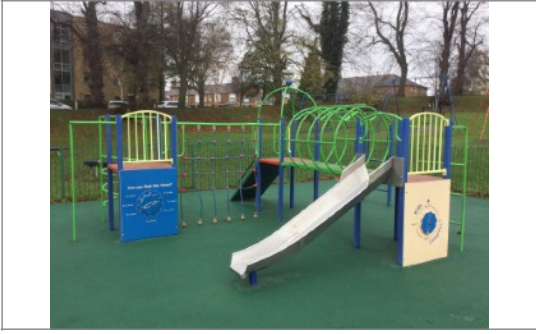
Item	Junior Multiplay Unit				
Supplier	Park Leisure				
Surface	Wet Pour				
Risk Rating Overall	Very Low	Low	Medium	High	Unacceptable
			8

Rust/corrosion evident to unit. Recommendation: Monitor for deterioration.	7
---	---	----------

Loose fixing(s) evident. Recommendation: Retighten loose fixing(s) as required.	8
---	--	----------

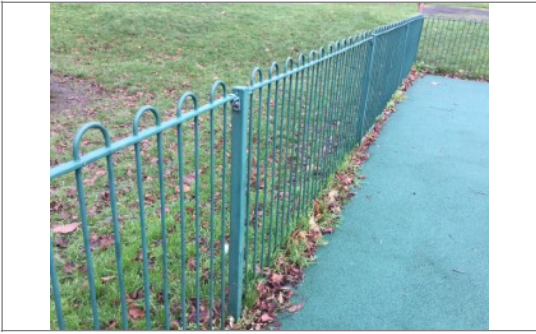
Item	Fencing				
Supplier	Unknown				
Surface	N/a				
Risk Rating Overall	Very Low	Low	Medium	High	Unacceptable
			8

Loose fixing(s) evident. Recommendation: Retighten loose fixing(s) as required.	7
---	--	----------

As above finding. Recommendation: As above comment.	7
--	--	----------

Brick wall near gate is damaged. Recommendation: Repair as required.	8
---	---	----------

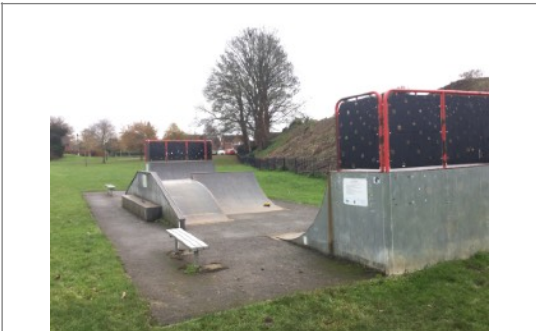
Item	Wheeled Sports Area				
Supplier	Caloo				
Surface	Concrete/Metal				
Risk Rating Overall	Very Low	Low	Medium	High	Unacceptable
				15

Transition issue - Gap between rolling surface and footplate in excess of 5mm. Recommendation: Repair this condition asap.	15
---	---	-----------

As above finding. Recommendation: As above comment.	15
---	--	-----------

Damage evident to coping on grind rail. Recommendation: Replace damaged coping.	8
---	--	----------

Rust/corrosion evident. Recommendation: Monitor for deterioration.	8
---	---	----------
