Play Area Safety Inspection Report – Operational
Oakham Town Council – Princess Avenue Fenced In Play Area

The inspection was carried out by Iain Mantle – RPII Certified Operational
Playground Inspector OP8020 - Date of Inspection 8th November 2023

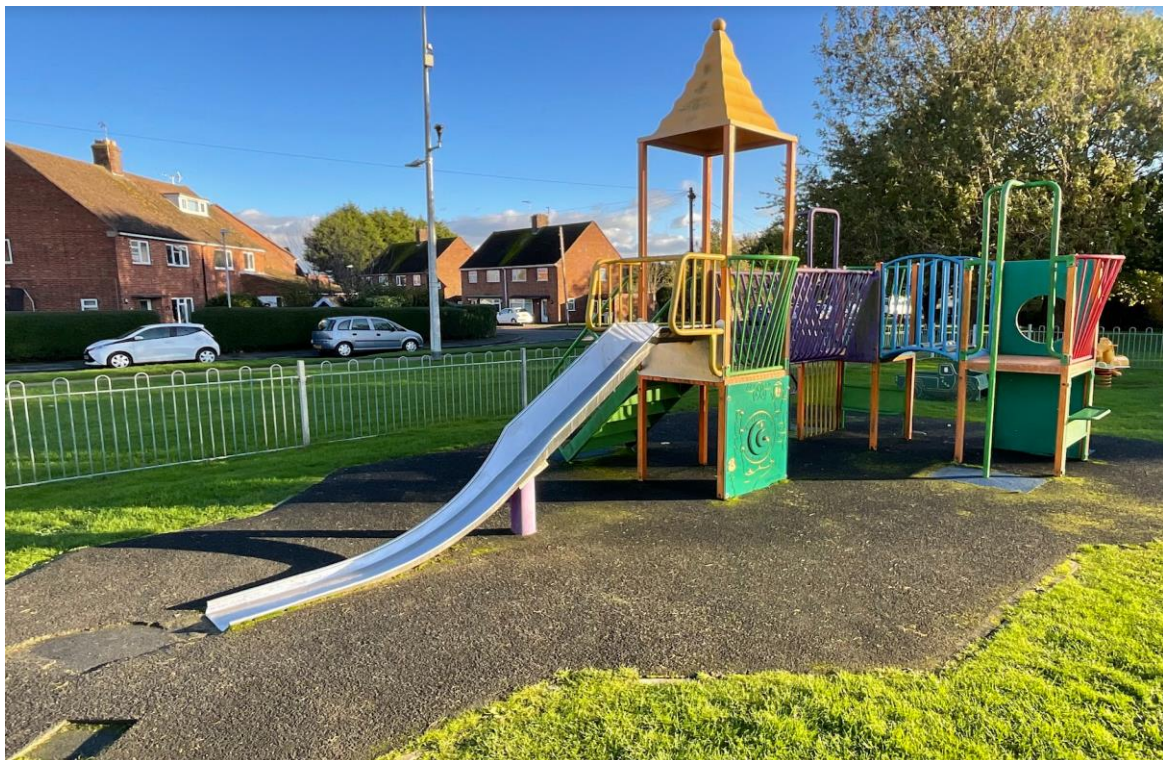
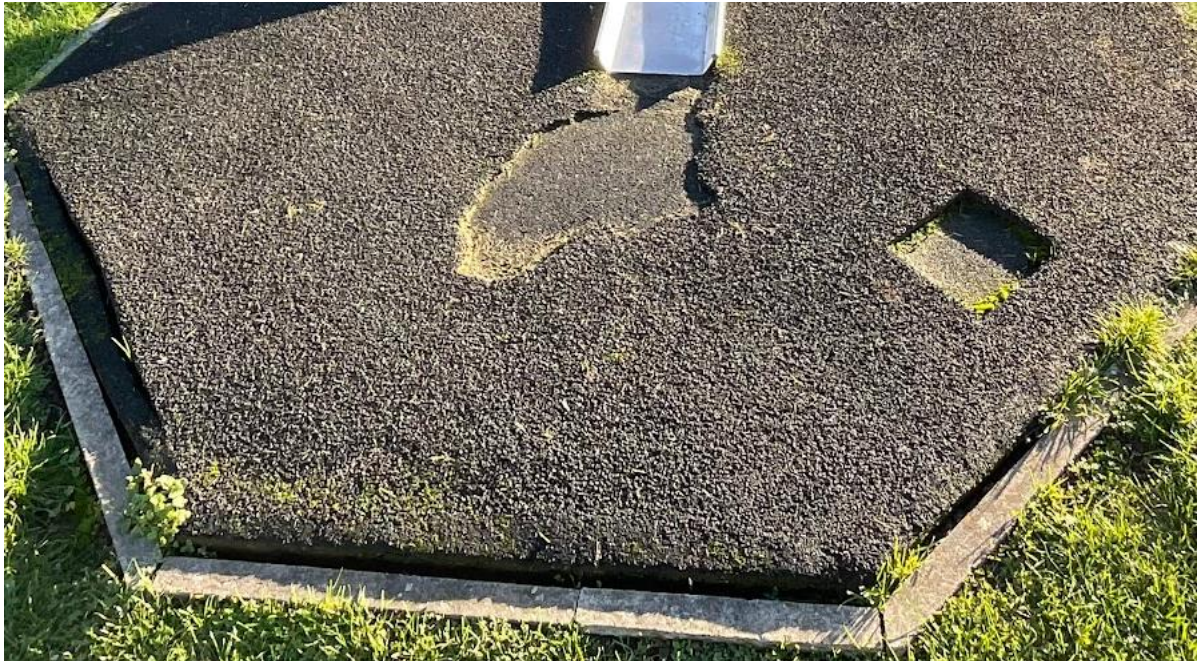
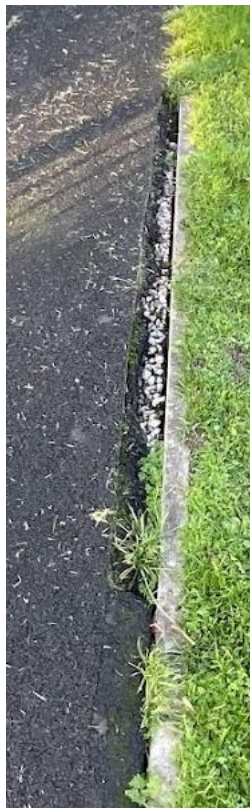
Item of Equipment-Multiplay Unit

Findings – Rubber Wetpour safety surface very slippery also wearing at the bottom of slide. There is shrinkage, separation from concrete edge, also the Wetpour is raised at the edge creating a trip hazard. Recommend repairing

Moderate Risk

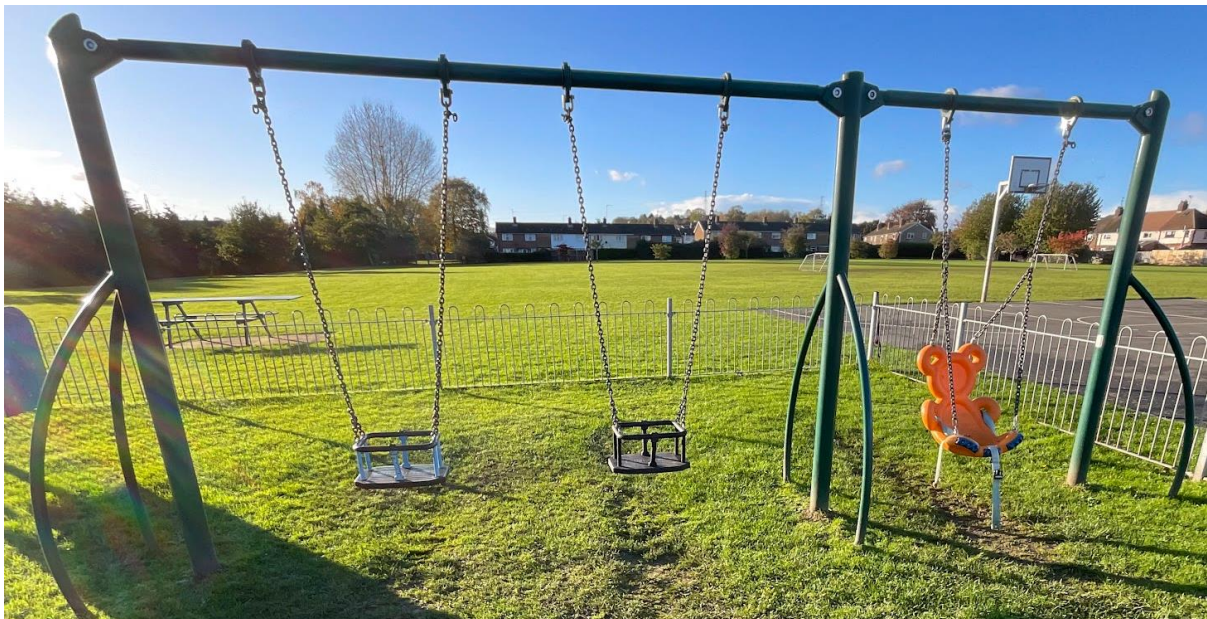
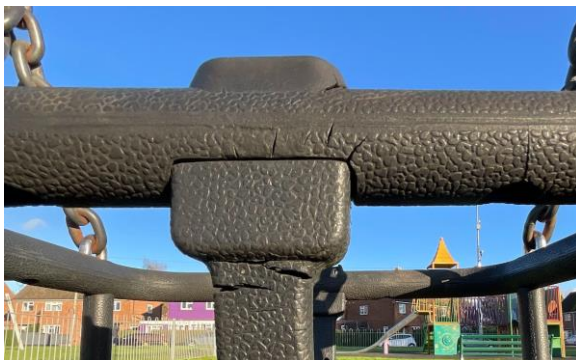
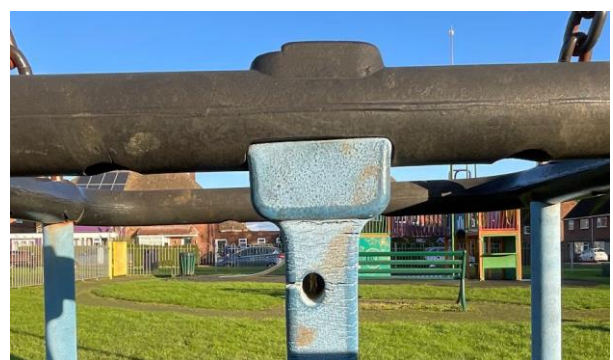
Item of Equipment-Toddler swing

Findings – The surface was wet and slippery, recommend monitoring weekly during winter months. Both cradle seats show small cracks appearing on centre support straps

Risk Very Low

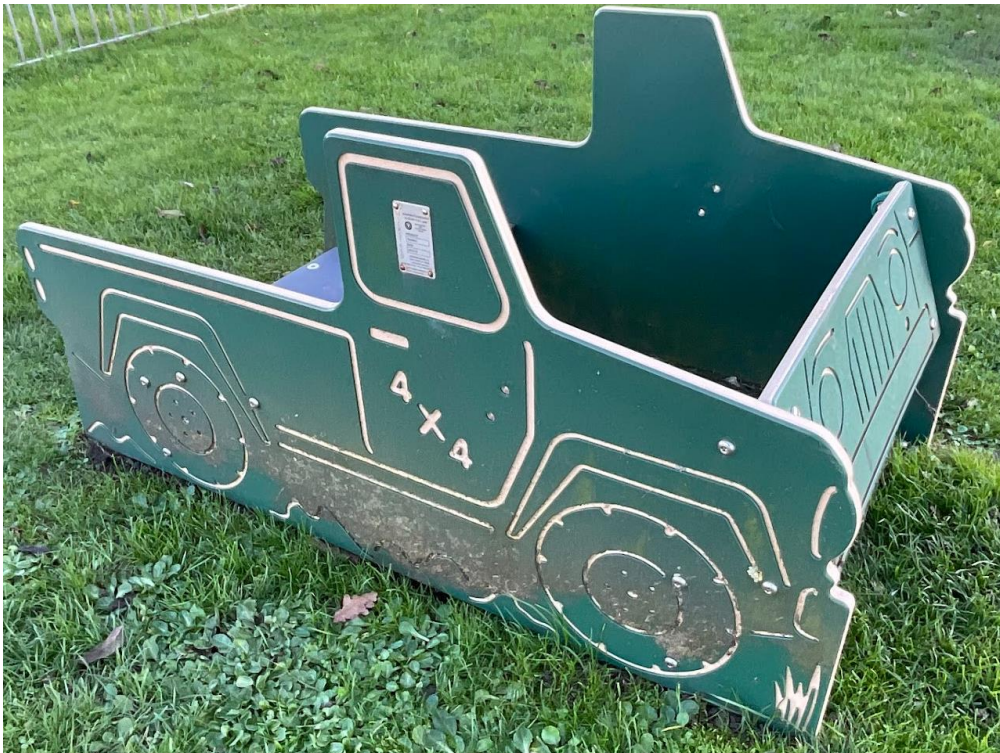
Item of Equipment- Play Car

Findings – Several parts missing from car reducing the play value

Risk Very Low

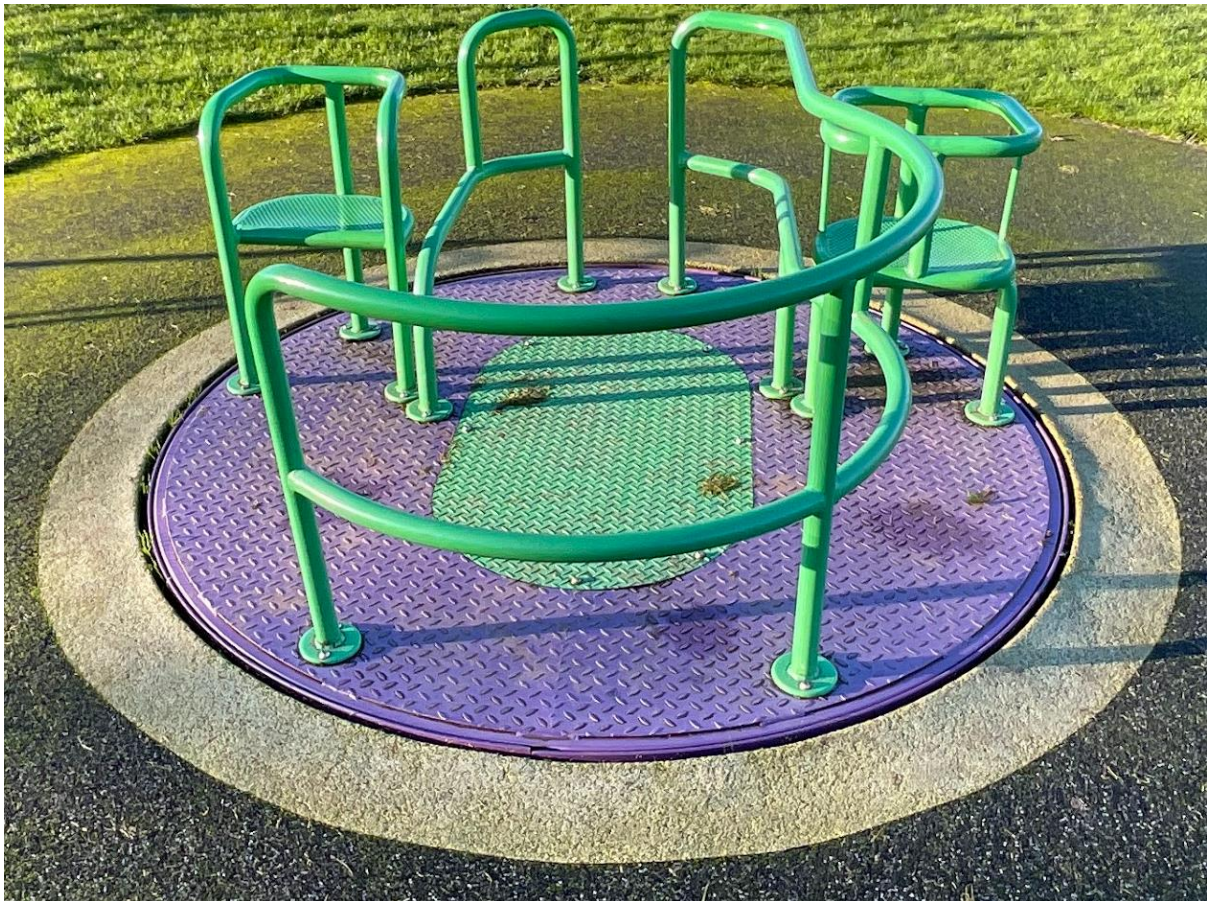
Item of Equipment- Inclusive Roundabout

**Findings – Roundabout is now almost impossible to turn reducing the play value.
Requires immediate attention**

Risk - Low

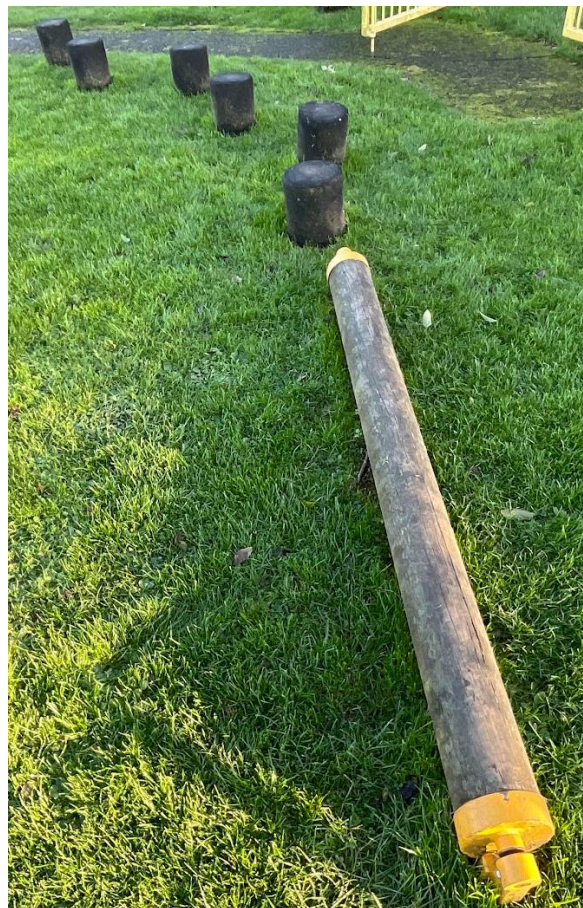
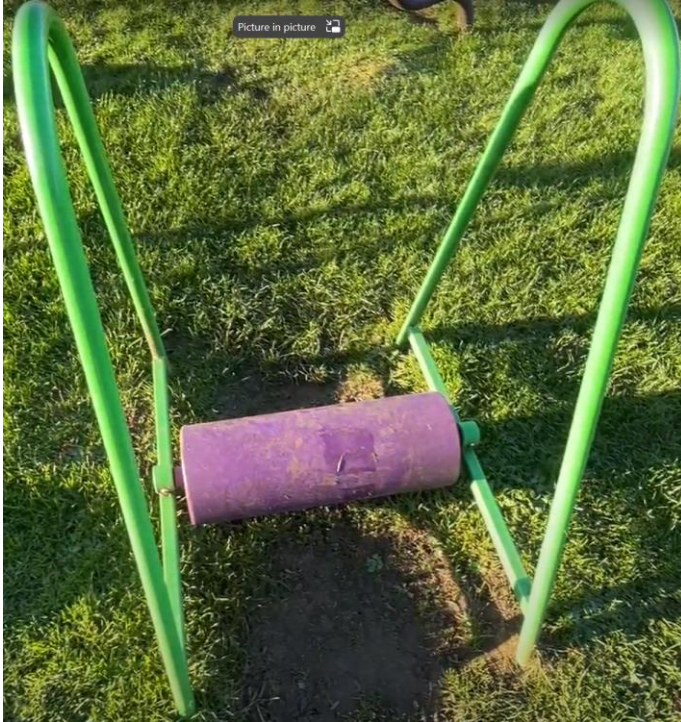
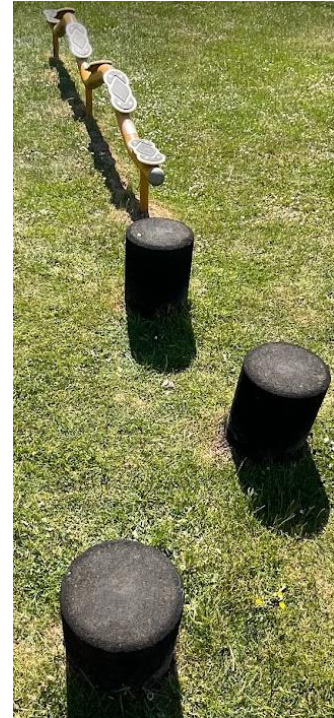
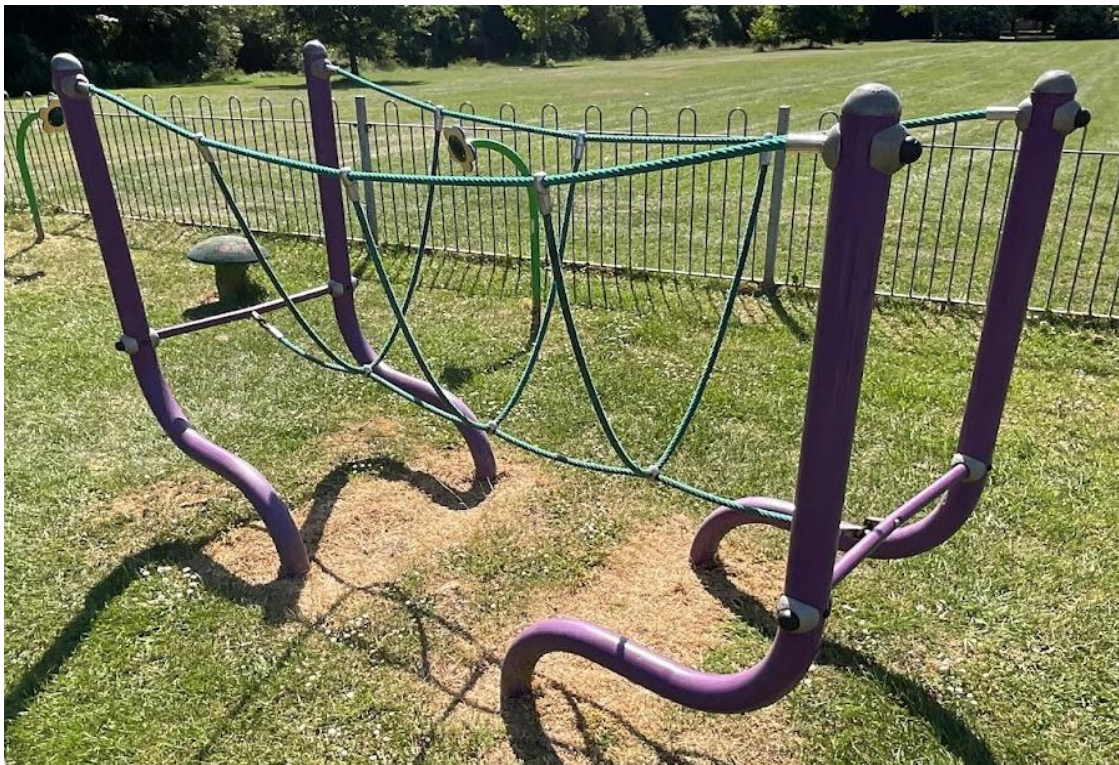
Item of Equipment- Steel Trim Trail

Findings – The log roll is very stiff. Rolling barrel extremely squeaky and dry, All of the stepping logs next to the log roll are slightly loose in the ground. All three items would benefit from some maintenance.

Risk - Low

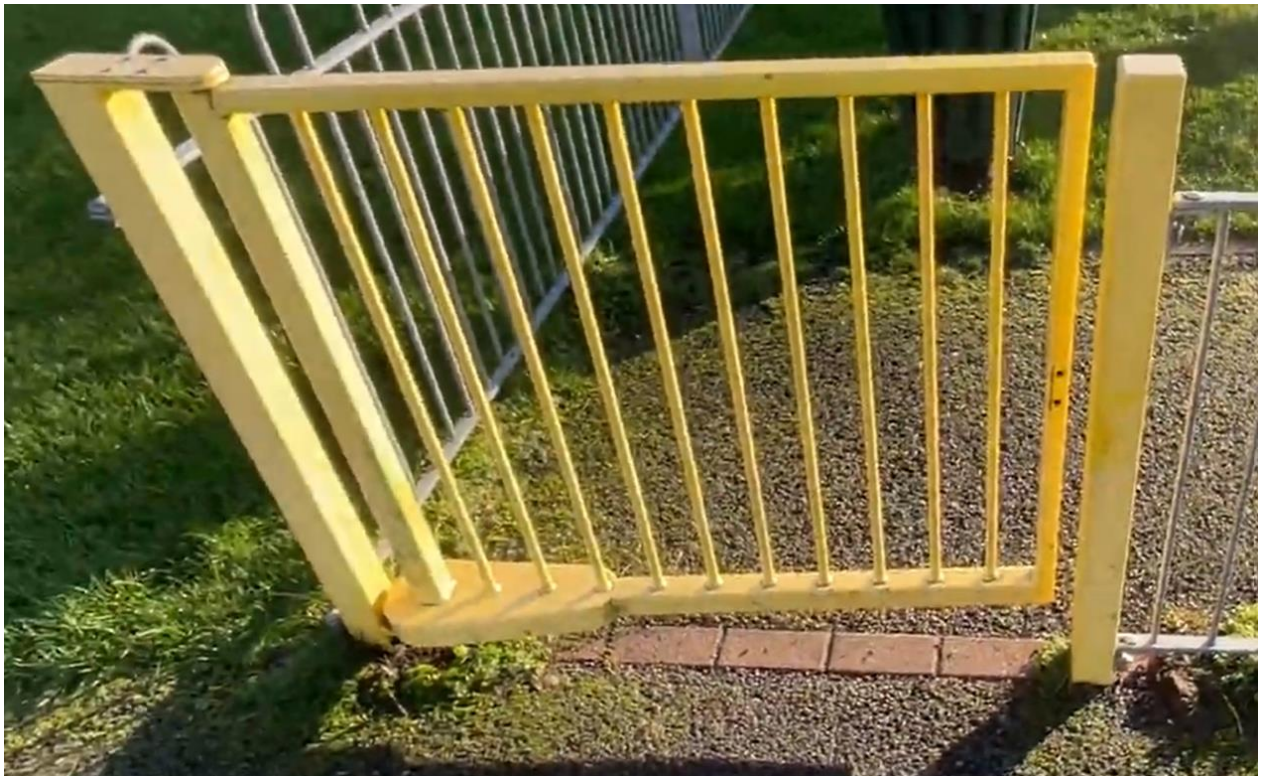
Item of Equipment- Entrance Gate

Findings – Gate closes to quickly maintenance recommended, gate should close between 4-8 seconds. Also slam plate missing.

Risk - Low
