Annual Inspection Report

Willow Crescent Play Area

Client:	Oakham Town Council
Address:	Rol House, Long Row, Oakham, Rutland, LE15 6LN
Date:	27th November 2025
Inspector:	Jamie Haynes

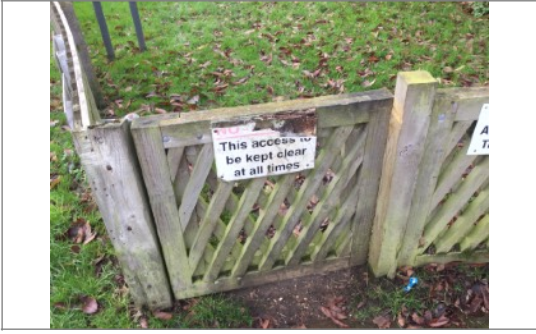
Item	Gates & Fencing				
Supplier	Unknown				
Surface	N/a				
Risk Rating Overall	Very Low	Low	Medium	High	Unacceptable
			10

Decay evident to gate & fencing. Recommendation: Replace decayed elements as required.	10
---	---	----

As above finding. Recommendation: As above comment.	10
---	--	----

Finger trap evident to gate. Recommendation: Consider adjustments to gate.	8
---	---	---

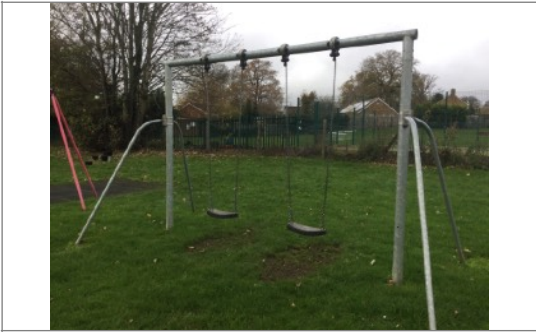
Item	1 Bay 2 Flat Swing				
Supplier	Kompan				
Surface	Grass Matting				
Risk Rating Overall	Very Low	Low	Medium	High	Unacceptable
			10

Missing end cap evident to crossbar. Recommendation: Replace missing end cap.	7
---	--	---

Chain/connecting link(s) wear evident. Recommendation: Replace at 40% dia wear.	10
--	--	----

As above finding. Recommendation: As above comment.	10
---	--	----

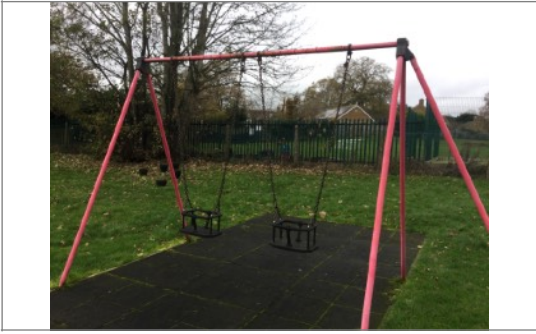
Item	1 Bay 2 Cradle Swing				
Supplier	Wicksteed				
Surface	Rubber Tiles				
Risk Rating Overall	Very Low	Low	Medium	High	Unacceptable
			8

Gaps evident in rubber tiles. Recommendation: Monitor to repair this condition.	7
---	--	---

Chain/connecting link(s) wear evident. Recommendation: Monitor to replace at 40% dia wear.	8
---	---	---

Slight damage evident to seats. Recommendation: Monitor this condition.	8
---	--	---

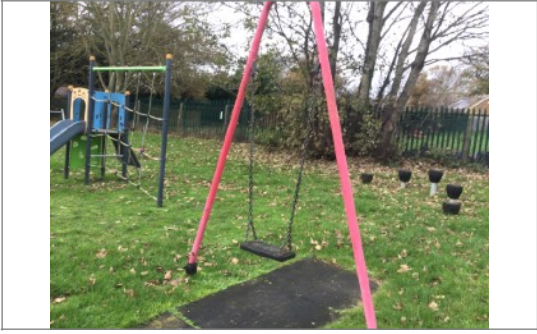
Item	1 Bay 1 Flat Swing				
Supplier	SMP				
Surface	Rubber Tiles				
Risk Rating Overall	Very Low	Low	Medium	High	Unacceptable
		7

Damage evident to rubber protection. Recommendation: Replace protection.	4

Gaps evident in rubber tiles. Recommendation: Monitor to repair this condition.	7

Chain/connecting link(s) wear evident. Recommendation: Monitor to replace at 40% dia wear.	7

Wear evident to bearings/fixings. Recommendation: Replace worn elements as required.	7

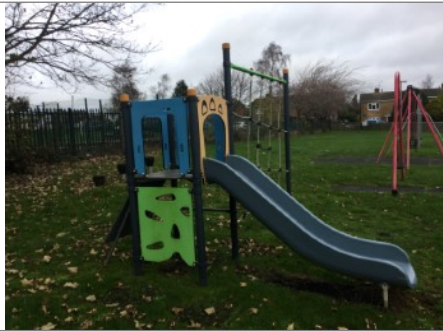
Item	Multiplay Unit				
Supplier	Kompan				
Surface	Grass Matting				
Risk Rating Overall	Very Low	Low	Medium	High	Unacceptable
		6

Missing plastic cap(s) evident.

Recommendation:
Replace missing cap(s).

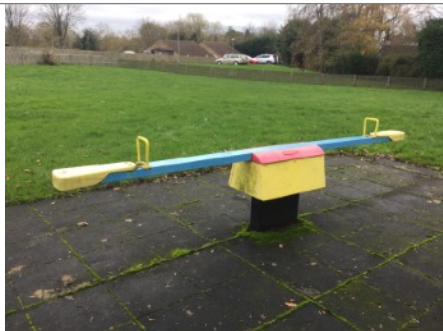
Item	Seesaw				
Supplier	Wicksteed				
Surface	Rubber Tiles				
Risk Rating Overall	Very Low	Low	Medium	High	Unacceptable
		7

Gaps evident in rubber tiles.

Wear evident to bearing.

Loose fixing(s) evident.

Damage evident to seats.

Recommendation:
Monitor to repair this condition.

Recommendation:
Consider replacing worn bearings.

Recommendation:
Retighten loose fixing(s) as required.

Recommendation:
Consider replacing damaged seats.

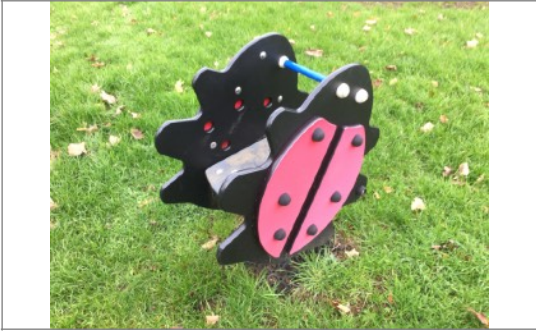
Item	Ladybird Spring Rocker				
Supplier	Kompan				
Surface	Grass Matting				
Risk Rating Overall	Very Low	Low	Medium	High	Unacceptable
		6

Missing plastic cap(s) evident.
Recommendation:
 Replace missing plastic cap(s).

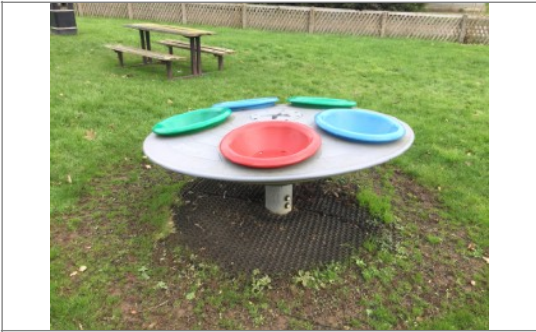
Item	Roundabout				
Supplier	Kompan				
Surface	Grass Matting				
Risk Rating Overall	Very Low	Low	Medium	High	Unacceptable
		7

Missing fixing evident to unit.
Recommendation:
 Replace missing fixing.

Damage evident to surfacing.
Recommendation:
 Replace damaged surfacing.

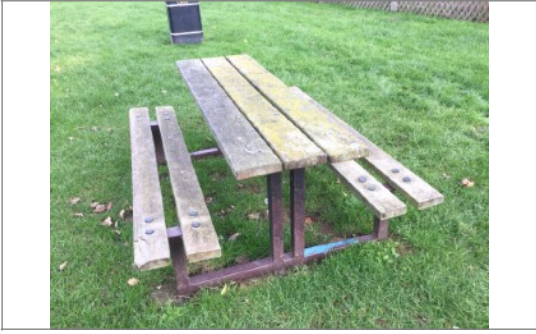
Item	Seating				
Supplier	Unknown				
Surface	N/a				
Risk Rating Overall	Very Low	Low	Medium	High	Unacceptable
		7

Decay/damage evident to unit.
Recommendation:
 Monitor for deterioration.

Multiple missing fixings evident.
Recommendation:
 Replace missing fixings.

As above finding.
Recommendation:
 As above comment.
