Play Area Safety Inspection Report – Operational  
Oakham Town Council – Princess Avenue Main Play Area

The inspection was carried out by Iain Mantle – RPII Certified Operational  
Playground Inspector OP8020 - Date of Inspection 16th June 2023

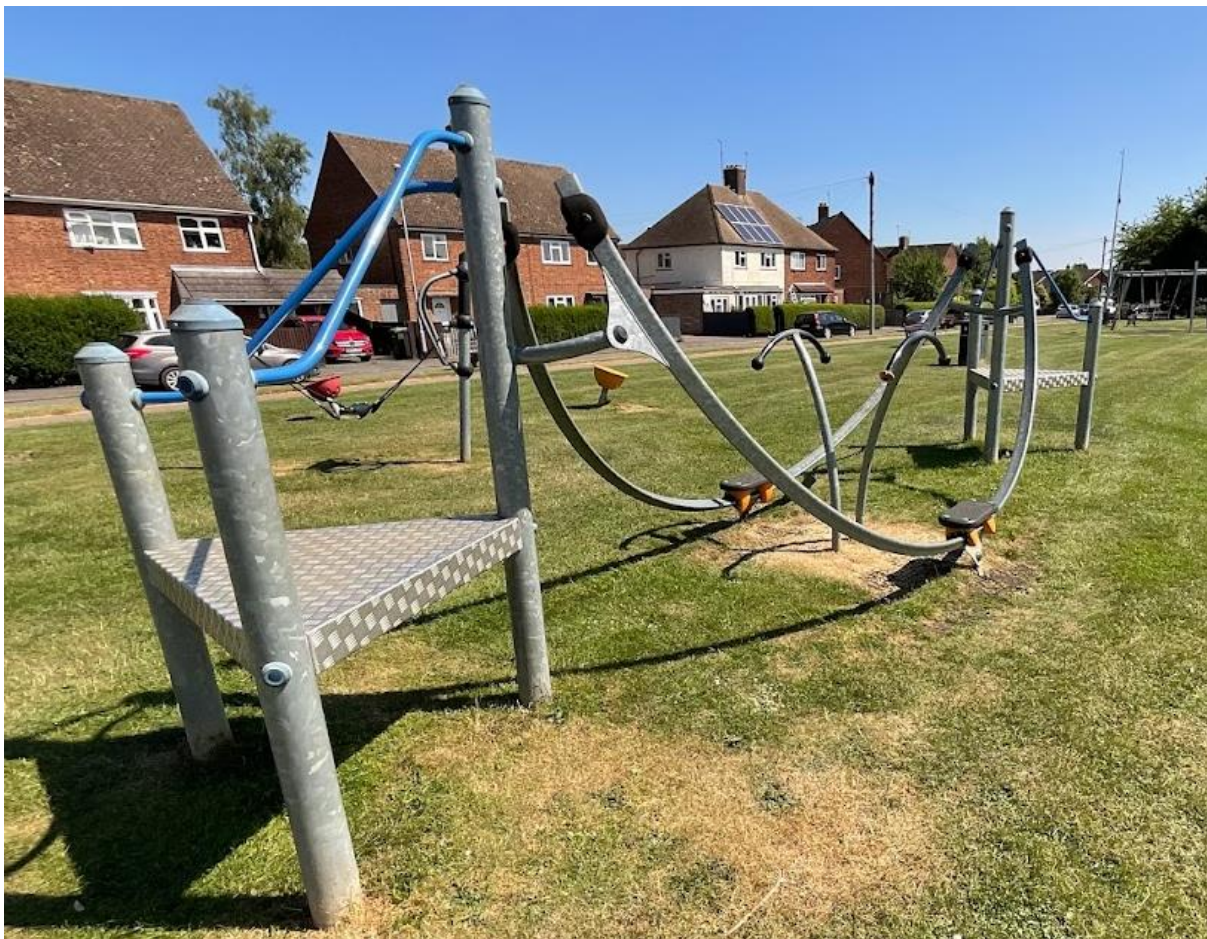
**Item of Equipment – Skate Unit**

**Findings – Slight play in blue hand rail monitor / bearings showing signs of wear on foot plates monitor**

**Risk Low**

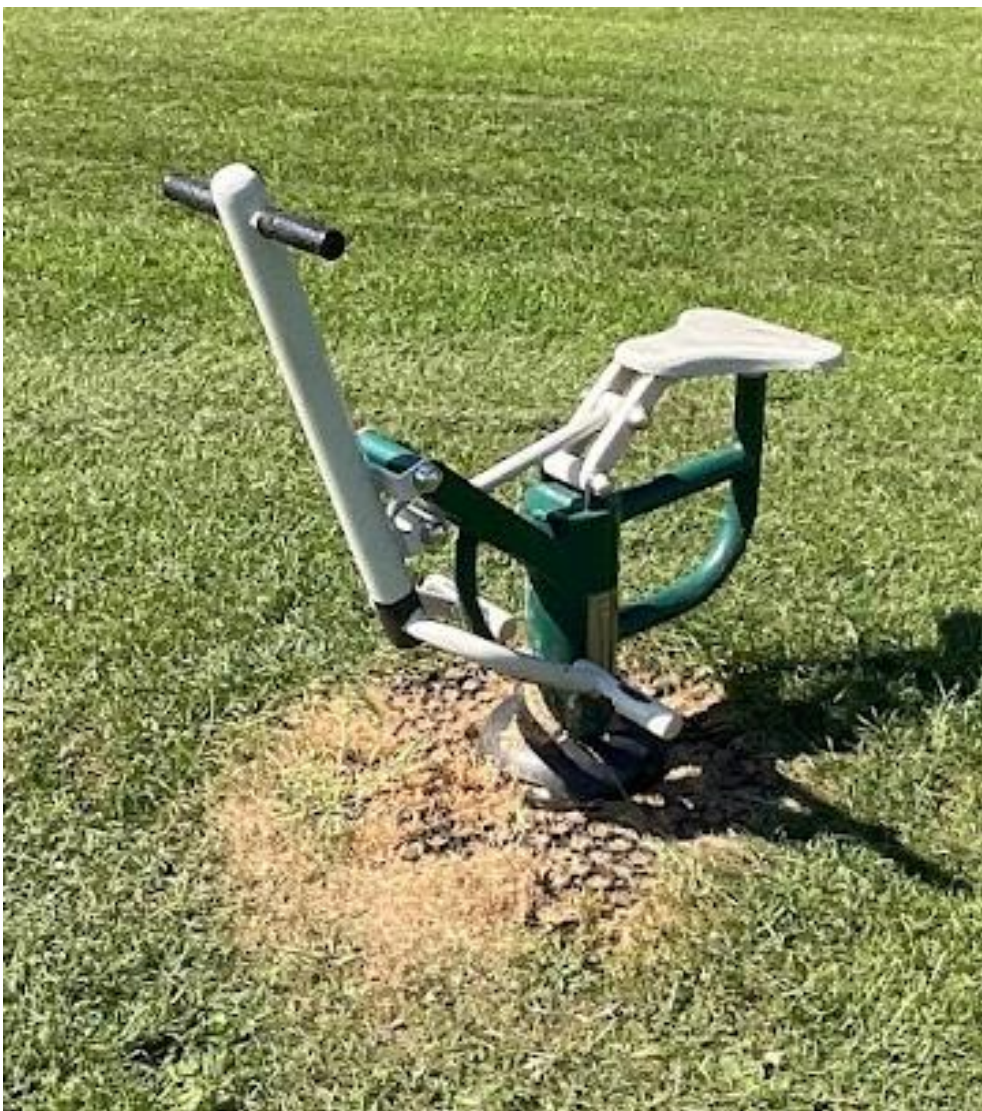
**Item of Equipment – Horse Rider**

**Findings – Signs of wear and tear, and corrosion monitor for deterioration**

**Risk Very Low**
