## Play Area Safety Inspection Report – Operational Oakham Town Council – Princess Avenue Fenced In Play Area

The inspection was carried out by Iain Mantle – RPII Certified Operational  
Playground Inspector OP8020 - Date of Inspection 12<sup>th</sup> August 2024

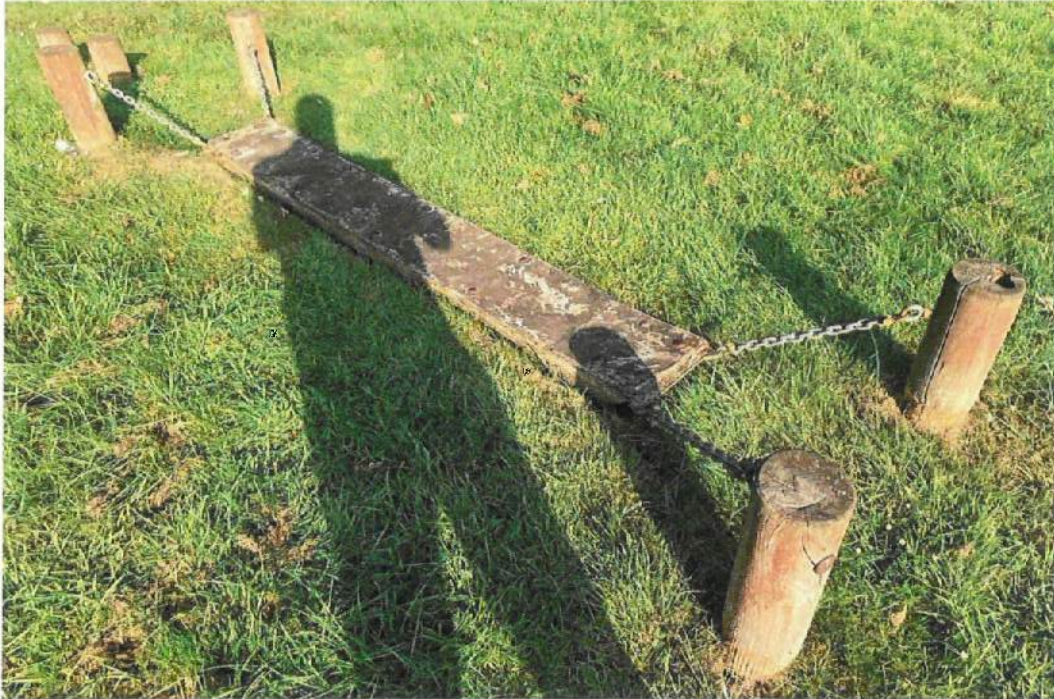
**Timber bridge support leg has failed requires replacing**
