## Play Area Safety Inspection Report – Operational Oakham Town Council – Willow Crescent Play Area

# The inspection was carried out by Iain Mantle – RPII Certified Operational Playground Inspector OP8020 - Date of Inspection 16th June 2023

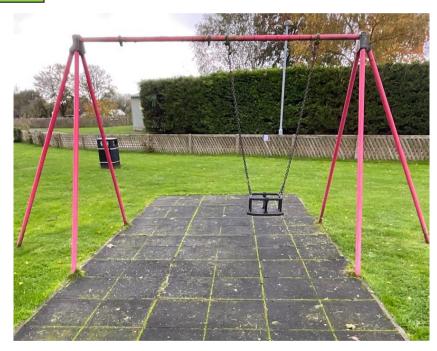
Item of Equipment- 2 Bay 2 Cradle Seat Swing

Findings – Left hand cradle seat has been removed, right hand seat is showing signs of cracking on rubber support strap.

#### **Low Risk**

Rubber tiles extremely slippery when wet during the autumn and winter months Recommend monitor weekly during these months.

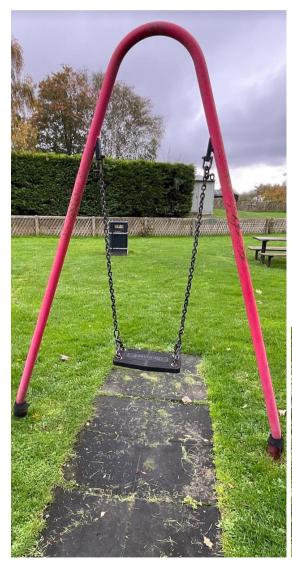
**Item of Equipment- 1Bay 1 Seat Swing**

Findings – Rubber tiles are prone to getting extremely slippery during autumn / winter months. Recommend monitoring weekly during these months.

Gap has appeared between tiles.

## **Risk Very Low**

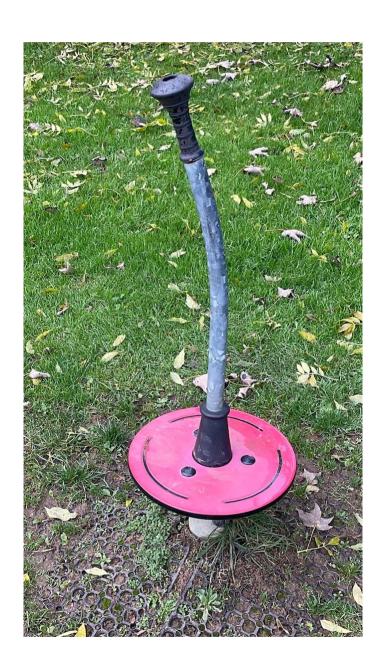
## **Item of Equipment-Spinning Pole**

Findings – Slight play in bearing recommend monitoring

Risk – Low

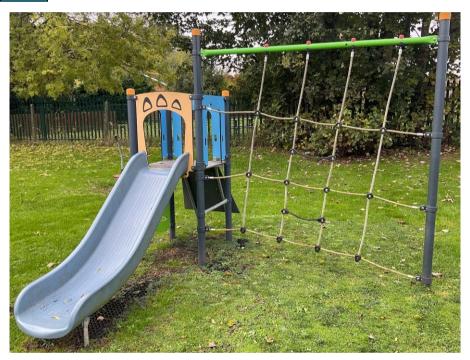
**Item of Equipment- Multi-Play Unit**

Findings - Cap missing from rock ramp

## **Risk Very Low**

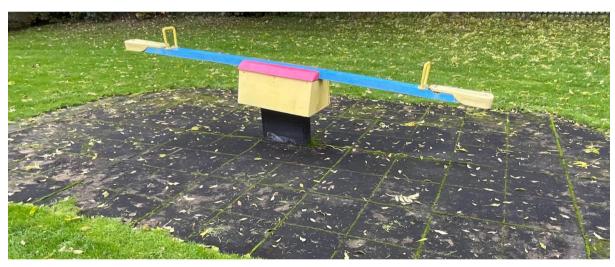
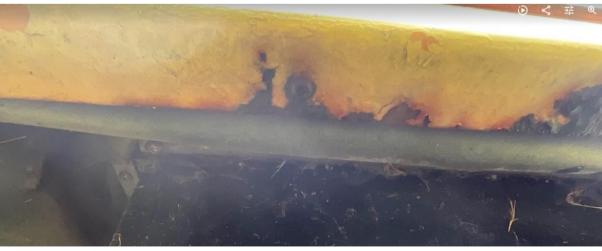
**Item of Equipment- See Saw**

Findings – Some corrosion on underside of See Saw rubber cracked & misssing exposing mechanism. Rubber tiles are prone to getting extremely slippery during autumn / winter months. Recommend monitoring weekly during these months.

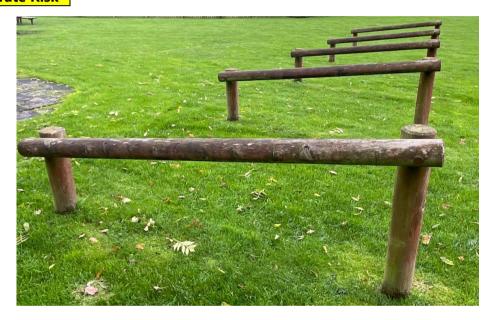
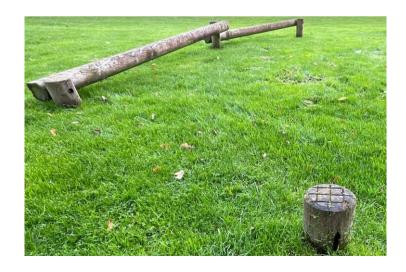
#### **Item of Equipment-Timber Trim Trail**

Findings – Many parts of the trim trail are showing signs of wear and tear, timbers are rotting and need replacing as soon as possible please see photos. (Please see other notes below)

#### **Moderate Risk**

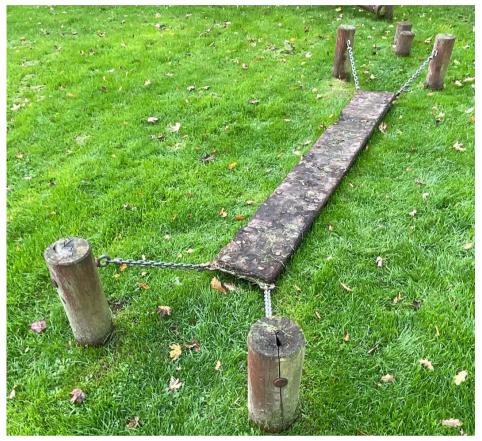
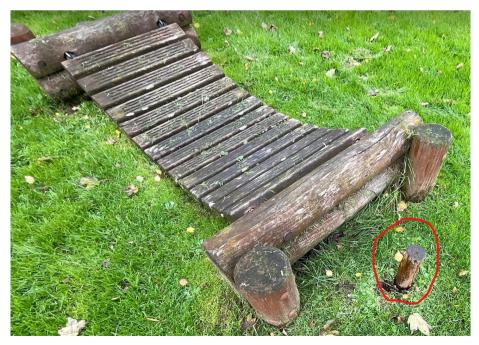
Stepping log has rotted away leaving thin stump if fallen on could cause injury

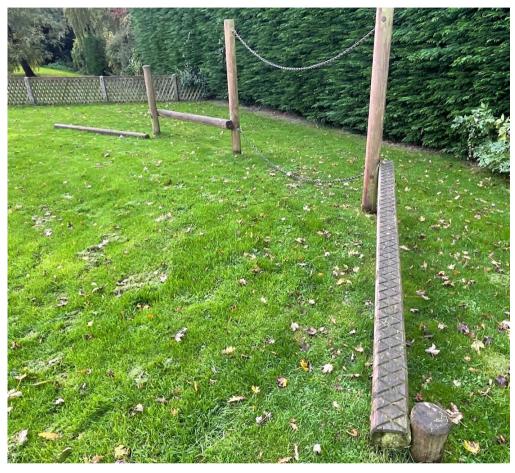
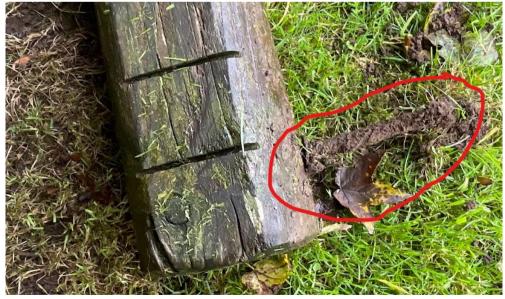
Slopping balance beam come away from below piece of equipment exposing long bolt. This timber should now have be removed by Oakham Town Council

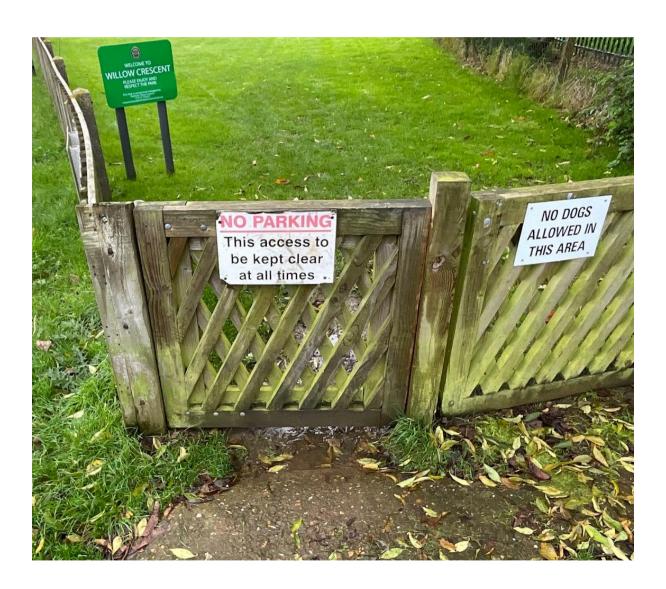
## **Item of Equipment- Wooden Entrance Gate**

Findings – This gate closes much too quickly. Recommended speed for gate closure is between 4-8 seconds.

Risk - Low
