Annual Inspection Report

Princess Avenue Open Play Area

Client:	Oakham Town Council
Address:	Rol House, Long Row, Oakham, Rutland, LE15 6LN
Date:	27th November 2025
Inspector:	Jamie Haynes

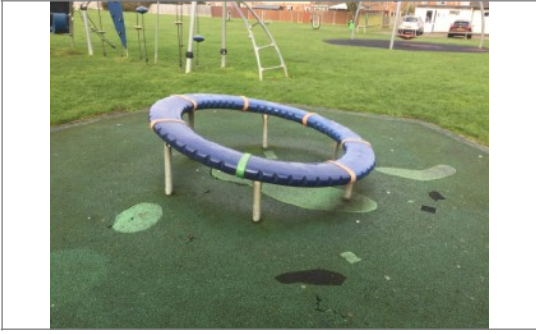
Item	Supernova				
Supplier	Kompan				
Surface	Wet Pour				
Risk Rating Overall	Very Low	Low	Medium	High	Unacceptable
			8

Splits/damage evident to wet pour. Recommendation: Monitor to repair this condition.	8
---	---	---

As above finding. Recommendation: As above comment.	8
---	--	---

Rubber seal missing from underside of unit. Recommendation: Replace missing seal.	8
---	--	---

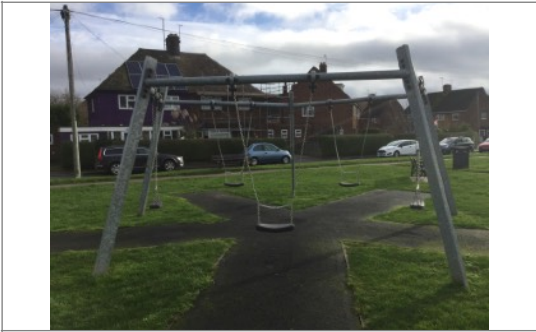
Item	Group Swing				
Supplier	Kompan				
Surface	Wet Pour				
Risk Rating Overall	Very Low	Low	Medium	High	Unacceptable
		7

Wet pour shrinkage in places. Recommendation: Monitor to repair this condition.	7
---	--	---

Slight wear evident to bearings. Recommendation: Monitor this condition.	6
--	---	---

Chain/connecting link(s) wear evident. Recommendation: Monitor to replace at 40% dia wear.	7
---	---	---

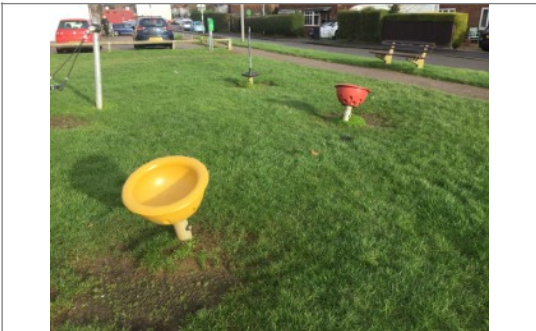
Item	Spinning Bowls				
Supplier	Kompan				
Surface	Grass Matting				
Risk Rating Overall	Very Low	Low	Medium	High	Unacceptable
		4

No faults found during the inspection. Recommendation: No action required, monitor this item.	4
---	--	---

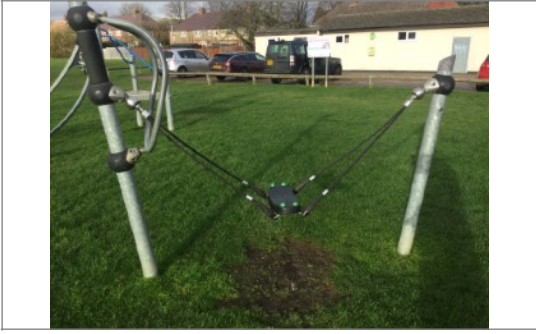
Item	Skate Swing				
Supplier	Kompan				
Surface	Grass Matting				
Risk Rating Overall	Very Low	Low	Medium	High	Unacceptable
		7

Splits event to 4x rubber protection.
Recommendation:
 Monitor this condition, consider improvements.

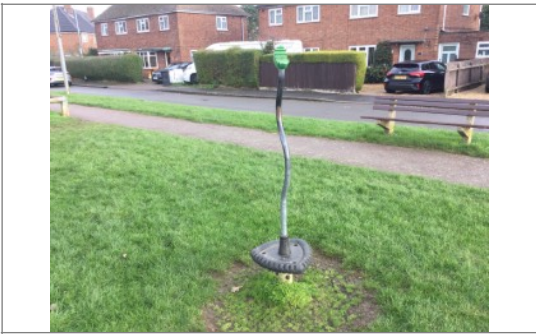
Item	Spinning Pole				
Supplier	Kompan				
Surface	Grass Matting				
Risk Rating Overall	Very Low	Low	Medium	High	Unacceptable
		7

Wear evident to bearing.
Recommendation:
 Consider replacing worn bearing.

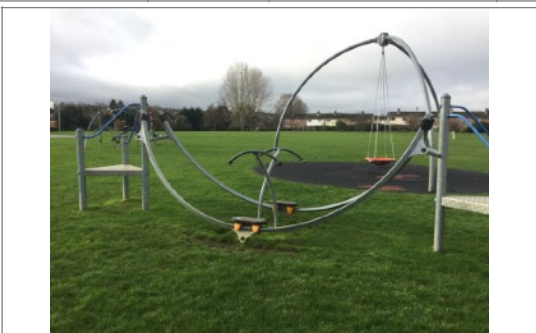
Item	Duel Skate Swing				
Supplier	Kompan				
Surface	Grass Matting				
Risk Rating Overall	Very Low	Low	Medium	High	Unacceptable
			8

Slight damage evident to seat.
Recommendation:
 Monitor this condition.

Missing fixing evident to 1x skate.
Recommendation:
 Replace missing fixing.

Slight wear evident to mechanism.
Recommendation:
 Monitor this item.

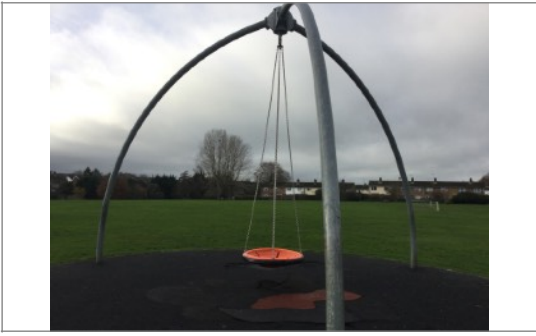
Item	Basket Swing				
Supplier	Kompan				
Surface	Wet Pour				
Risk Rating Overall	Very Low	Low	Medium	High	Unacceptable
			12

Damage evident to wet pour. Recommendation: Carry out repairs asap.	10

Missing end caps evident to rubber protection causing possible finger entrapment. Recommendation: Replace asap.	10

Chain/connecting link(s) wear evident. Recommendation: Replace worn elements asap.	12

As above finding. Recommendation: As above comment.	12

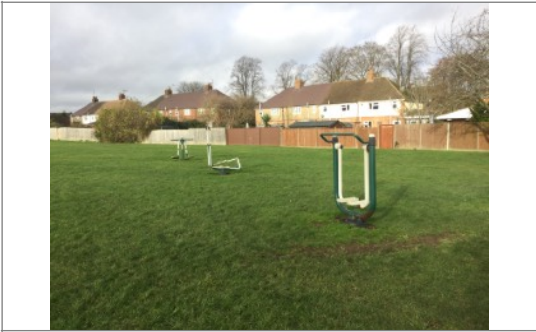
Item	Outdoor Gym Equipment				
Supplier	Ashland's Fitness				
Surface	Grass Matting				
Risk Rating Overall	Very Low	Low	Medium	High	Unacceptable
					21

Severe rust/corrosion evident. Recommendation: Remove/replace all units.	21

As above finding. Recommendation: As above comment.	21

Missing rubber protection evident. Recommendation: Replace missing protection.	10

As above finding. Recommendation: As above comment.	10

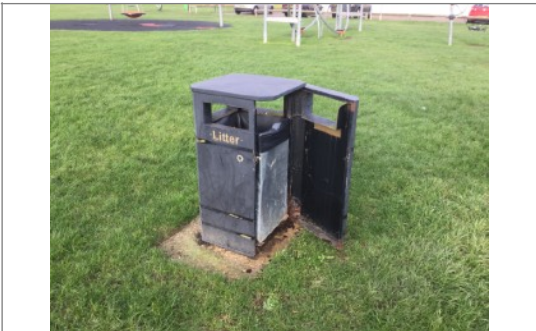
Item	Bin				
Supplier	Unknown				
Surface	N/a				
Risk Rating Overall	Very Low	Low	Medium	High	Unacceptable
		6

Bin not locked at time of inspection. Recommendation: Consider to keep locked at all times.	6
	Recommendation:	
	Recommendation:	
	Recommendation:
